LIQUEFACTION DAMAGE TO THE GROUND DURING THE 1983 NIHONKAI-CHUBU (JAPAN SEA) EARTHQUAKE IN AKITA PREFECTURE, TOHOKU, JAPAN

ABSTRACT

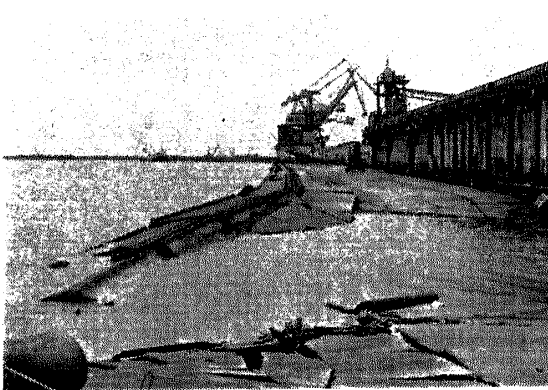
Photo. 1 shows the quay wall on part of Nakajima No. 1 quay, which bulged and sank into

Photo. 1 Sunken quay wall and bulging revetment at Nakajima No. 1 Quay in Akita Port (Site A7).

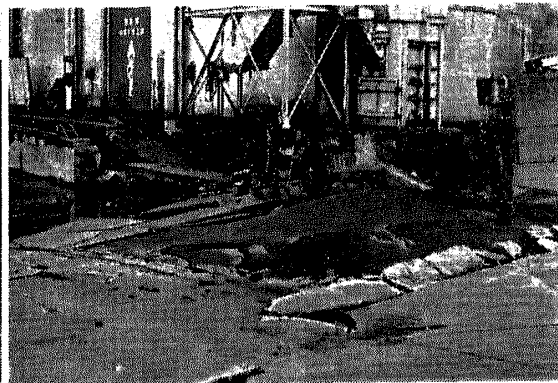
the sea. Photo. 2 shows the collapse of the apron stage and the destructoin of the warehouse's foundation. Photo. 3 shows the broken leg of an unloading machine at No. 2 quay buried in the ground.

Photo. 2 Damaged warehouse and collapsed apron stage at Nakajima No. 1 Quay in Akita Port (Site A7).

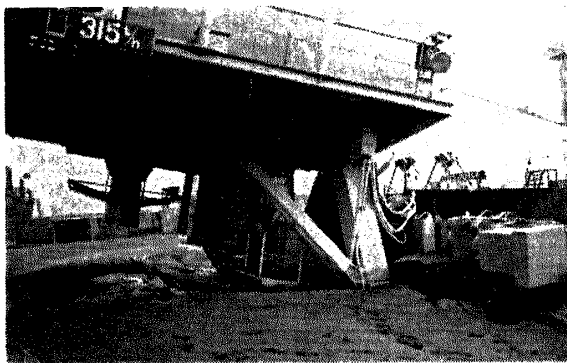
Photo. 3 Leg of unloading machine at Nakajima No. 2 Quay in Akita Port, broken and buried in the ground (Site A7). Photograph from Mr. Fukuhara (Tokyo Institute of Technology).

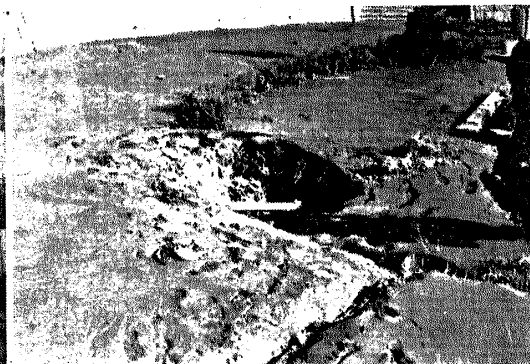
At Mukohama (Site A8), a reinforced concrete quay wall was tilted approximately 10 degrees, and the apron stage settled and cracked. Many sand volcanos were present around No. 3 quay which had been constructed about the time of this earthquake. Photo. 4 shows sand volcanos found around a bench in Mukohama Park.

Photo. 4 Sand blow out near a bench at Mukoh-hama Park (Site A8).

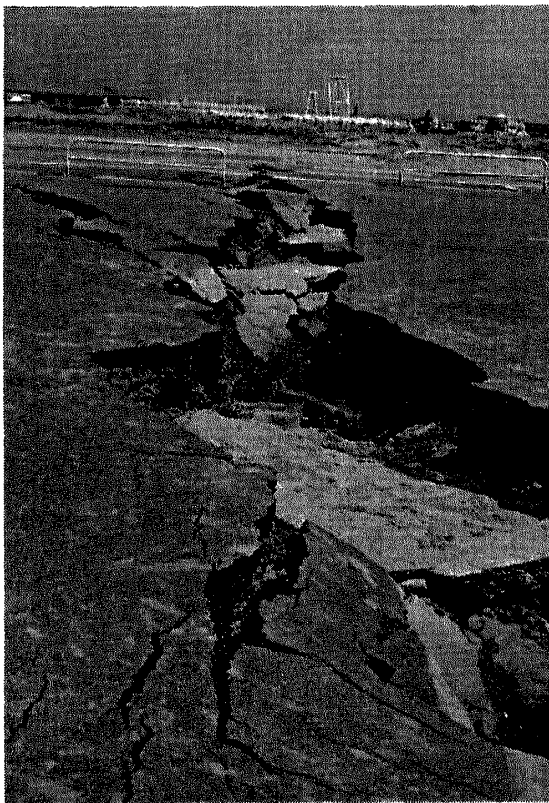
At Gaikoh (outer harbor, Site A10), a great many cracks ran in every direction and the ground surface heaved. Photo. 5 shows sand volcanos inside of open cracks in the parking lot. A caisson quay wall was moved approximately 1 m, and the apron stage near it settled and collapsed. Maximum settlement of the apron was 1.5 m, as shown in Photo. 6. Almost all a warehouse's floors near the apron were collapsed except the footing beam and the reinforced concrete column heads were destroyed.

Photo. 5 Sand blow inside an open crack in the parking lot near the warehouse in Gaikou (outer port) Akiata Port (Site A10).

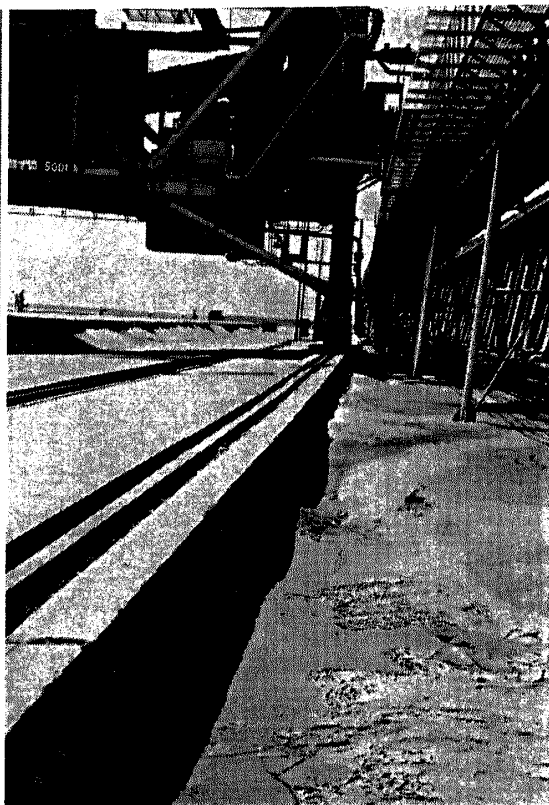
Photo. 6 Complete collapse of the apron stage at the quay wall in Gaikoh, Akita Port (Site A10).

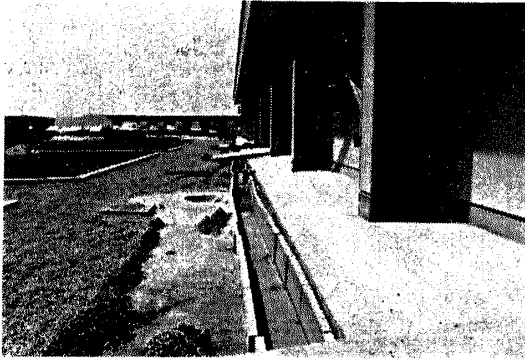
Photo. 7 Sand blows around a building at the Oga Industrial High School (Site E2).

on the ground surface (Photo. 7). The floor of an engineering workroom, a one-story building, showed a maximum subsidence of 40 cm. A house next to tennis courts was destroyed because the lot slipped and collapsed (See Photo. 8). An aerial photograph (Photo. 9) shows sand volcanos and cracks on the surface of the ground all around the high school and on house lots near the school, but there was neither liquefaction nor damage in weak paddies took place on Alluvial lowland. The liquefied materials at this high school were well sorted and fine-grained reclaimed sands with the mean particle size, D_{50} , of about 0.2 mm and the uniformity coefficient, U_c , of about 1.8 (Fig. 7).

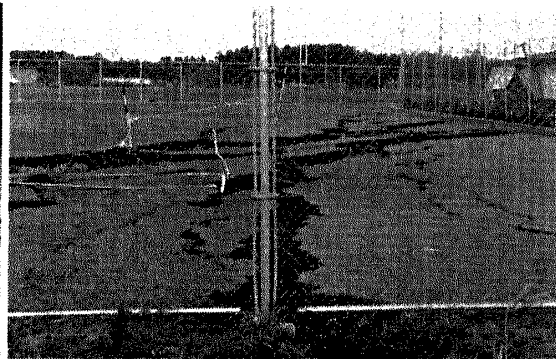
Photo. 8 Cracks in the tennis court at the Oga Industrial High School and damage to a wooden house that slipped due to collapse of its lot (Site E2).

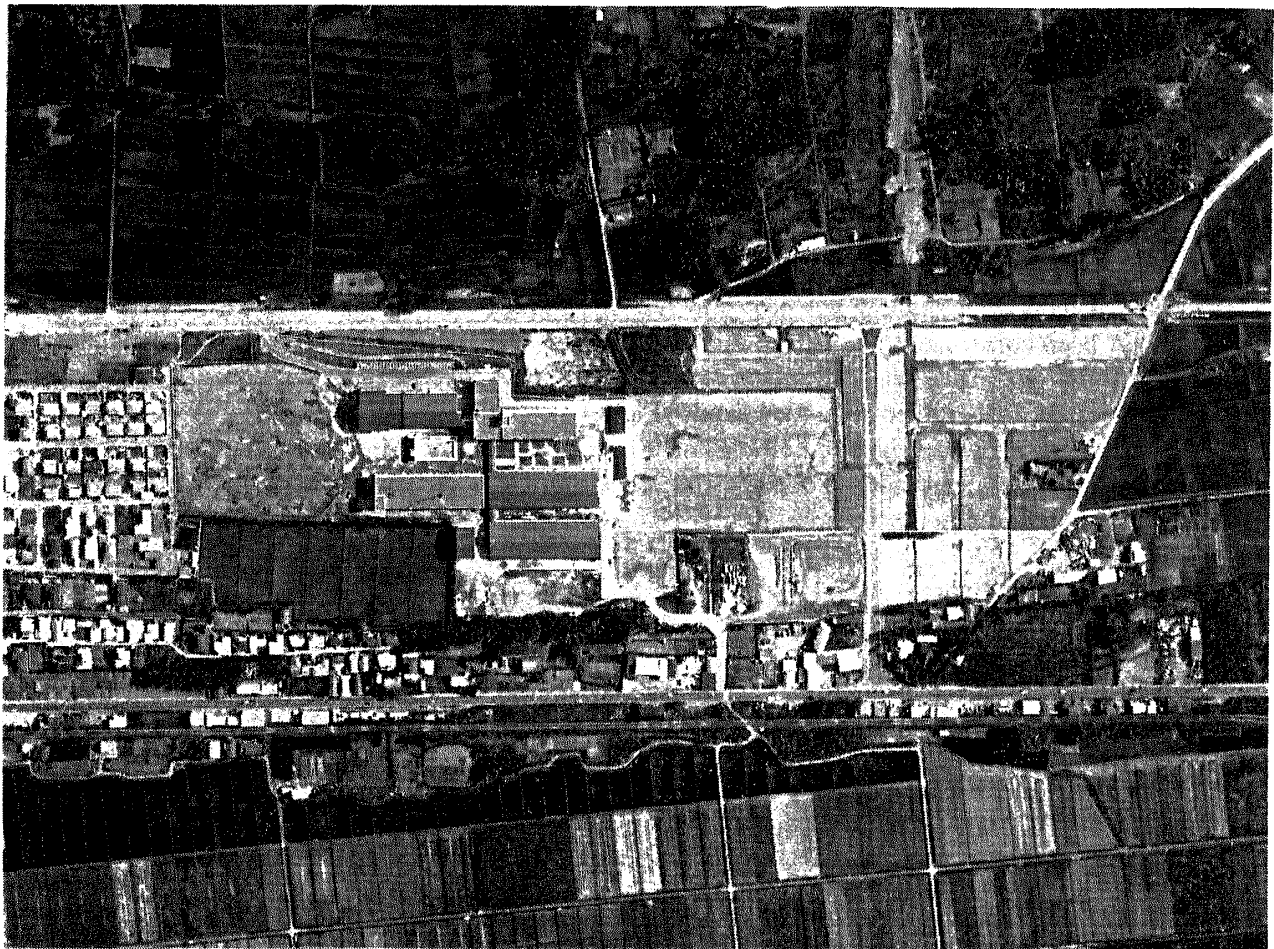
Photo. 9 Aerial photograph of the Oga Industrial High School taken the day of the 1983 Nihonkai-Chubu earthquake (Site E2).

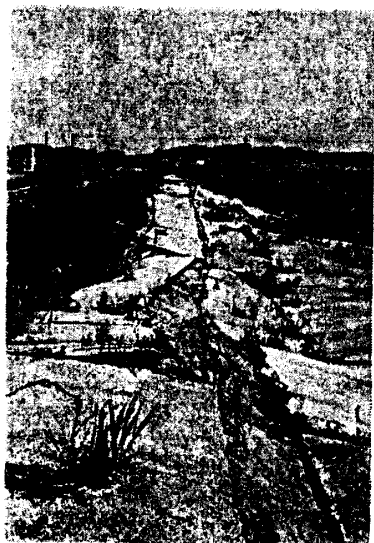
Photo. 10 Broken embankment along the northern part of the east intercepting drain in Hachirogata Lagoon.

At the northern end of the east intercepting drain dike, the embankment subsided more than 1 m, and the center line on the embankment road shifted about 1.4 m and heaved (Photos. 10–11). Waving and meandering of the embankment road also were found in parts of the east and west intercepting drains.

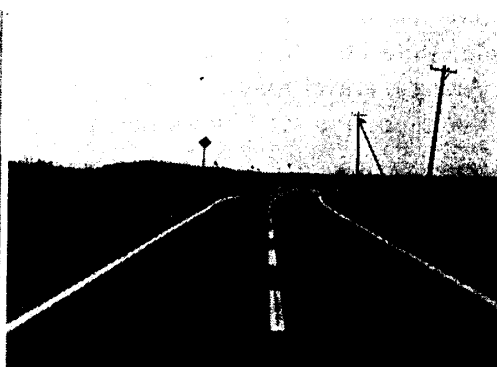
Photo. 11 Shifted embankment road, its center line moved 1.4 m in the northern part of the east intercepting drain in Hachirogata Lagoon.

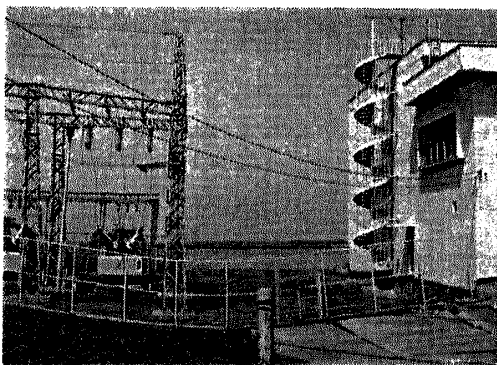
Photo. 12 Uneven subsidence of ground at the Northern Pumping station in Hachirogata Lagoon. (Site F2).

At the Northern pumping station (Site F2), ground visible from the building settled, and the foundation of the electronic substation subsided (Photo. 12). The bottom of the retaining wall bulged about 50 cm.

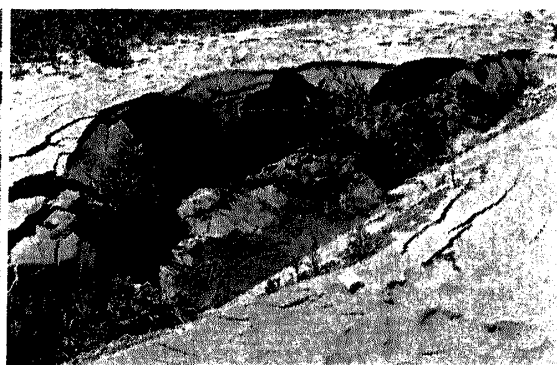
Photo. 13 Sand volcanos in the side gutter of the embankment road to the southern Ohgata Bridge in Hachirogata Lagoon.

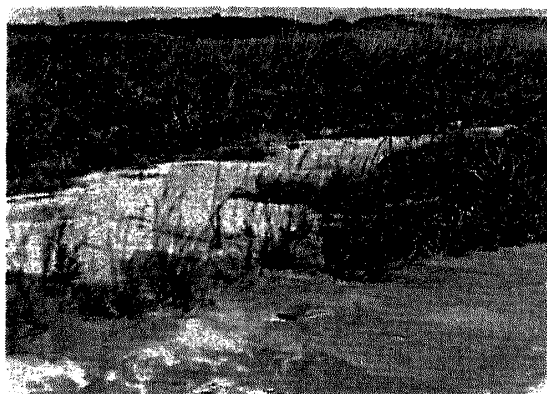
At the west intercepting drain dike, the embankment settled 0.5 to 1.0 m, in some parts the difference between the top of the embankment and the water level being less than 1 m. At nearby Gomyoko Bridge (Site F6), the subsidence was so great that the top of the embankment could not be seen. Along a gravel road and its gutter south of this bridge, along the west intercepting drain, sand volcanos and sand blows were present inside open cracks (Photo. 14). The access

Photo. 14 Sand volcanos along the gravel embankment road in the west intercepting drain at Hachirogata Lagoon.

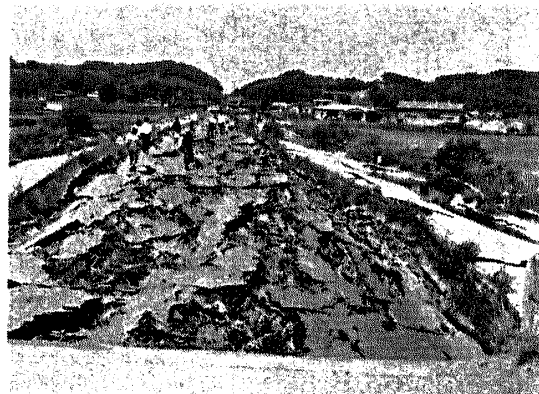
Photo. 15 Destruction of the access road to Gomyoko Bridge (Site F6).

road to the Gomyoko Bridge subsided and a great many cracks were formed on its surface (Photo. 15). Liquefaction was extensive in a paddy near the bridge.

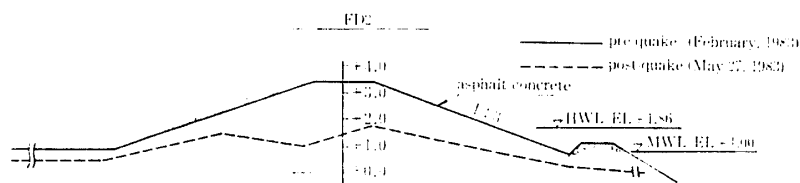
Fig. 8 Cross-section of a damaged embankment section of a frontal dike in Hachirogata Lagoon (Ref. [4]).

Fig. 8 of Higashiyama and Fujita [4] shows a post-quake (May 27th, 1983), cross section of the damaged embankment of the frontal dike. This damaged embankment, along all of the dike in the Hachirogata Lagoon was composed of sandy soil. The earthquake caused major damage to 208 ha. of paddies in Ohgata Village.

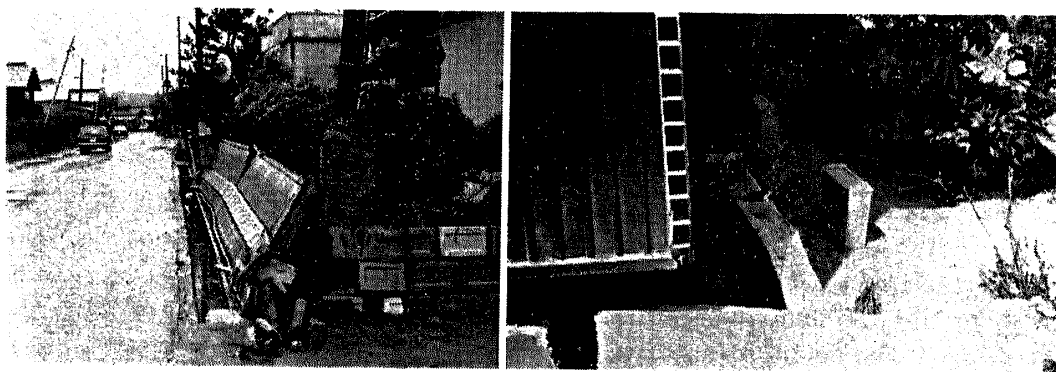
Photo. 16 Damage at Kami-Gomyoko bus stop in Wakami Town.

Photo. 17 Damage to the concrete footing of wooden house and a slipped shed at Gomyoko, Wakami Town (Site G5).

The detailed distribution of liquefaction locations at Tamanoike and Gomyoko, is shown in Fig. 10 which combines data from field investigations and aerial photographs of these sites. Photo. 16 shows damage near the Kami-Gomyoko bus stop. Photo. 17 shows a plain concrete strip footing without reinforcing steel that broke onto which the shed has slid.

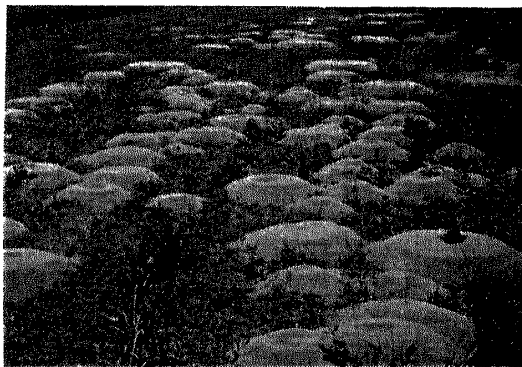
Photo. 18 Typical sand volcanos in fields at Gomyoko, Wakami Town (Site G5).

margins of the sand dunes. Photo. 18 shows typical miniature sand volcanos in a paddy. A crack with a depth of more than 1 m was present at this site.

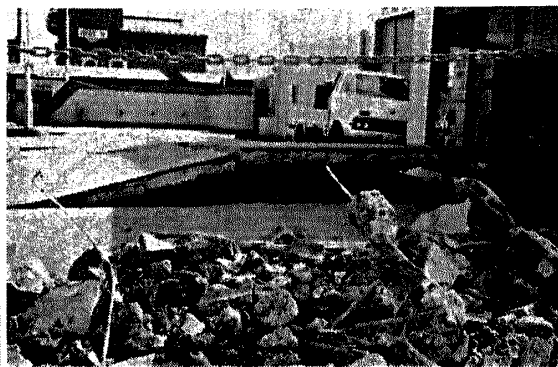
Photo. 19 Uplift of a buried oil tank 70 cm at a gas station in Kawatogawa, Noshiro City (Site I4). Photograph from Mr. Fukuhara (Tokyo Institute of Technology).

Koado (Site I11). At Kawatogawa, many gateposts and concrete block fences were tilted or destroyed. A buried oil tank at a gas station was raised about 70 cm, and the footing of a house and both edges of the road were badly broken (Photos. 19–20). Liquefied sand sample at the side of a road at Asanai was fine-grained with a mean particle size, D_{50} , of 0.33 mm and a uniformity coefficient, U_c , of 1.9 (Fig. 12). The detailed distribution of the liquefaction sites at Kawatogawa is shown in Fig. 13.

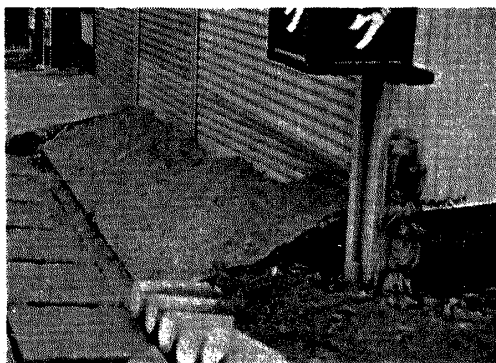
Photo. 20 Displaced side gutter along the road at Kawatogawa, Noshiro City (Site I4).

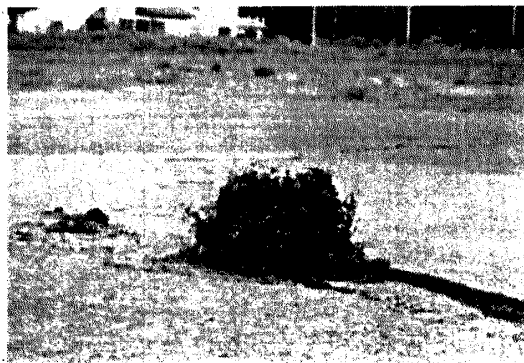
Poto. 91

Photo. 21 Boiling sand being spewn out at a baseball park (Site I11). Photograph from Noshiro City.

A remarkable photograph, taken by a resident (Photo. 21), shows water and boiling sand
