## BACK ANALYSIS TECHNIQUE FOR SLOPE STABILIZATION WORKS OF EMBANKMENT LANDSLIDE DUE TO FOUNDATION INSTABILITY

AZM S. AL-HOMOUD<sup>i)</sup>, ABDALLAH I. HUSEIN MALKAWI<sup>ii)</sup>, ADNAN A. BASMA<sup>iii)</sup>  
and AHMED B. TAL<sup>iv)</sup>

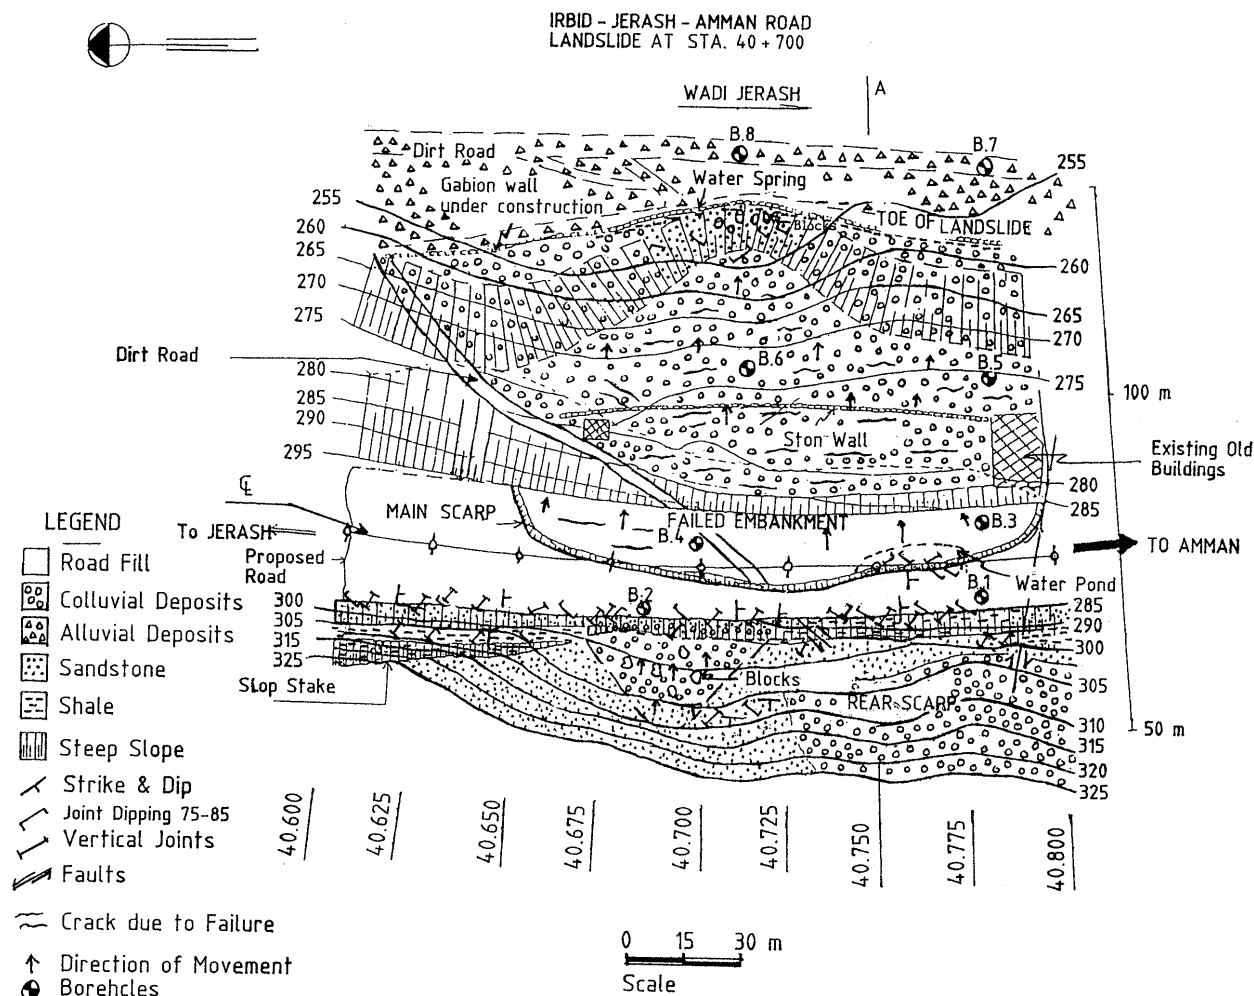
Fig. 3. Geotechnical map

hole B-8. Most of the area is vegetated except for the scarps. A number of local water seepages and springs were observed in the study area. Figure 3 illustrates the geomorphologically important areas and their subdivisional zones commencing at the wadi to the east and moving upslope of the study area. The embankment area is defined as that extending from the wadi on the east up to the existing road elevation. The upper slope area is defined as the area west of the existing road.

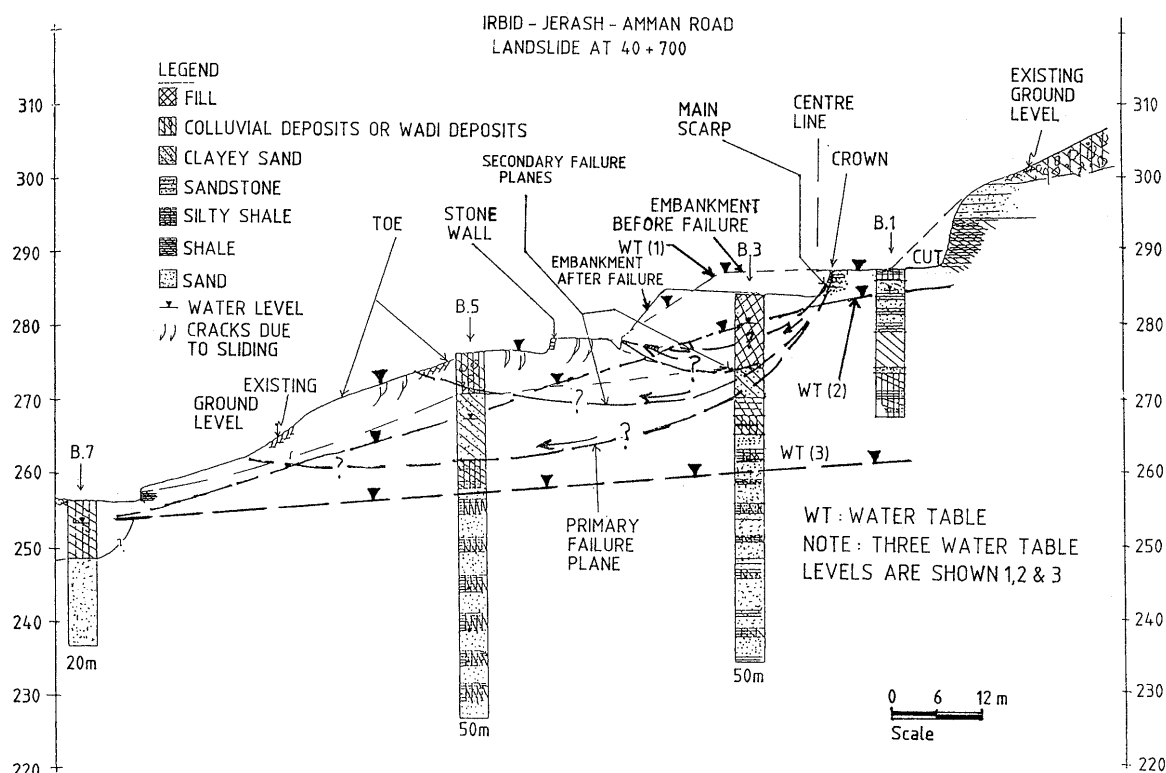
Fig. 4. General stratigraphic profile, configuration of failure planes and piezometric water elevations considered in stability analysis

Geometrical configuration of the landslide is shown on Fig. 4. The crown, main scarp and the toe of the landslide were clearly observed at the site. The ground movement below the road may be defined as a rotational circular to non-circular landslide. Possible failure planes along which landsliding may have occurred are shown on Figs. 4 and 5. Basically primary and secondary failure planes were identified.

Failure occurred mainly through colluvial deposits (Fig. 4). Colluvial deposits contain evidence of old landslides in failure planes throughout their mass. Furthermore, only residual shear strength properties can be mobilized along these planes and the non-cohesive nature of these properties make them extremely sensitive to the affect of pore water pressure. Also, because of the method of deposition, such planes are normally oriented parallel to the existing slope. In summary, therefore, in situ colluvial materials are, at best, metastable and make poor foundation materials.

The level of the water table at the time of failure is unknown. However, analysis was performed for three conditions of groundwater level (Fig. 4): (1) at ground surface (fully saturated condition) (identified in Fig. 4 as WT (1)); (2) intermediate (partially saturated condition) (identified in Fig. 4 as WT (2)); and (3) below failure surface (dry condition) (identified in Fig. 4 as WT (3)).

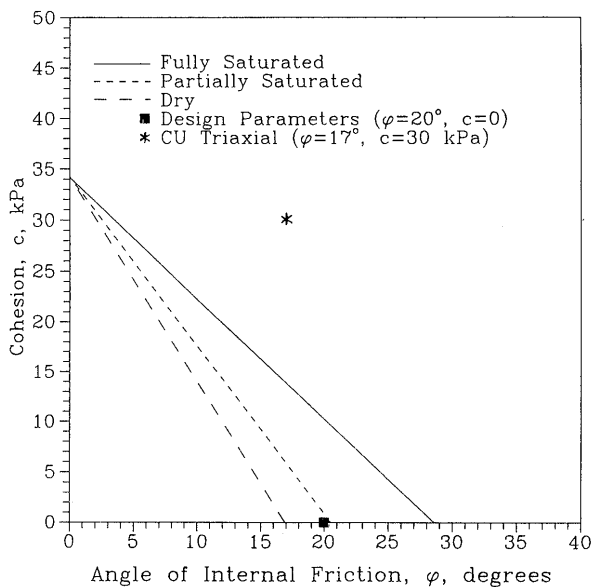
Fig. 5. Results of slope stability back analysis using Bishop method at different conditions of water table

one that connects the crest and the toe observed in the field and identified as the primary failure plane in Fig. 4. Tables 3 through 5 summarize the results of slope stability analyses. Moreover, Figs. 5 and 6 show the variation of calculated values of effective cohesion ( $c'$ ) with assumed values of effective angle of friction ( $\phi'$ ) that give a factor of safety of 1.0 for three conditions of ground water level for the Bishop and Janbu methods, respectively. Also shown on each Figure are the sets of  $c'$  and  $\phi'$  values obtained from consolidated undrained (CU) triaxial strength tests.
