# カトマンズ盆地における地震防災のための 建築物インベントリ調査と建物分布

## A Building Inventory & Building Typology Analysis in the Kathmandu Valley for Earthquake Disaster Assessment

大角 恒雄<sup>1</sup>, 金子 史夫<sup>2</sup>, 藤谷 秀雄<sup>3</sup>

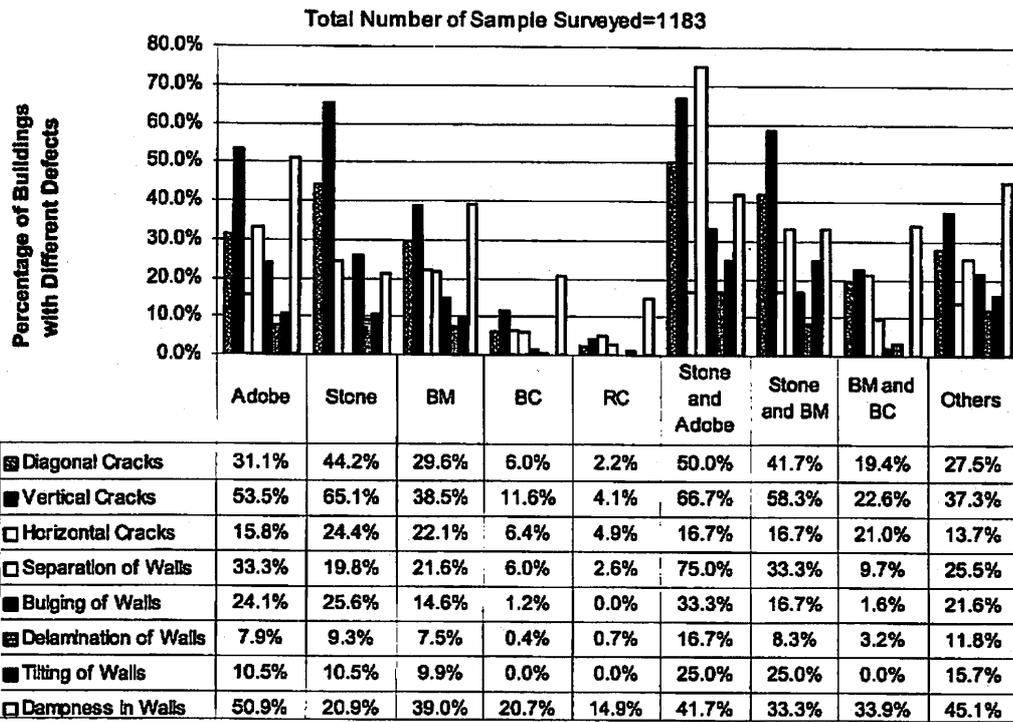
図-6 建物の損傷分類比率

損傷についての調査結果によれば、泥を目地等に用いた伝統的建物(AD, BM, ST)は、割れ目、剥離、はらみだし、壁の傾きの損傷・劣化を多く有する構造物であり、調査対象の半数をこえていた(図-6:巻末)。

それらの損傷・劣化の原因は、経年的な地盤の湿度の浸透、乾燥の繰り返しによって引き起こされていることが考えられる。これらの構造物は、耐震性が低減している。

一方、BCやRCのより新しいタイプのセメントを用いた構造では、BCの約12%が垂直の割れ目を、6%はせん断方向と水平の割れ目を有し、また、約6%は、壁の剥離を呈している。一方、RCの問題は、5%ではあるが、梁に沿って、水平の割れ目が発達している。これは明らかに施工不良および建材の品質管理の不徹底によるものであると考えられる。
