PRELIMINARY REPORT ON THE GAMAHARA TORRENT DEBRIS FLOW OF 6 DECEMBER 1996, JAPAN

Hideaki MARUI, Osamu SATO and Naoki WATANABE

Research Institute for Hazards in Snowy Areas, Niigata University

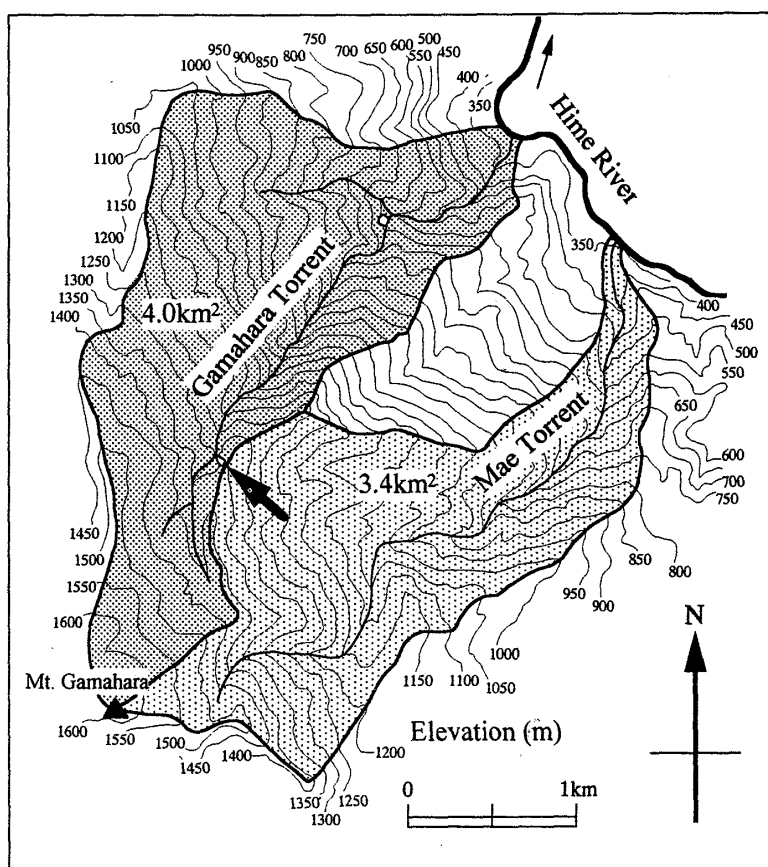
The Gamahara Torrent has a catchment area of 4.0km², a channel length of 4.6km, and is a very steep torrent with a mean bed inclination of 20 degrees. Its plane is shown in Fig. 2. The shape of the catchment area is asymmetrical and the slope on the right side is very steep and narrow, whereas the slope on the left is gentle and wide. The adjacent Mae Torrent has almost same size of catchment area, 3.4km². It has a symmetrical plain shape and a mean bed inclination of 15 degrees. The longitudinal profile of the Gamahara Torrent is shown in Fig. 3. Its bed inclination has a very steep shape in the middle part, becoming gentler in the upper part.

Fig. 2. Plane of the Gamahara and Mae Torrents. The arrow shows the slope failure in the upper area.

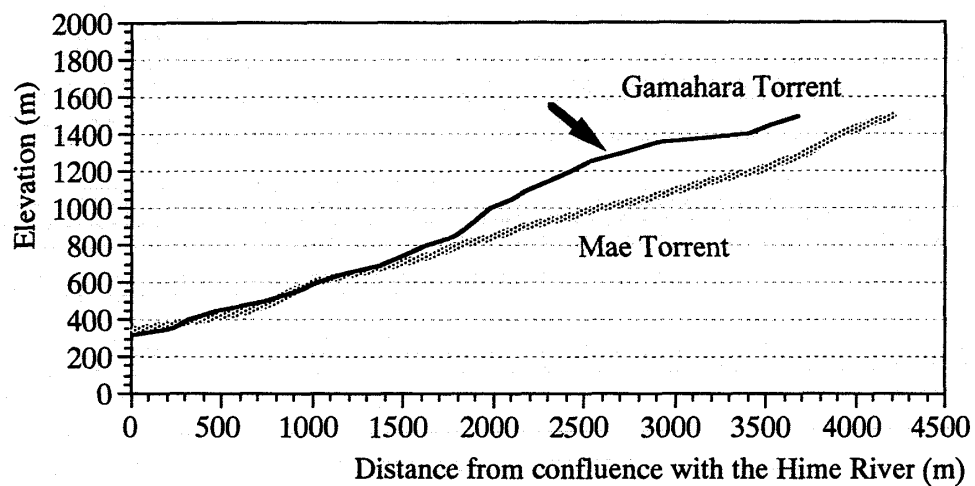
Fig. 3. Longitudinal profile down the main channel of the Gamahara Torrent. The arrow shows the slope failure in the upper area.

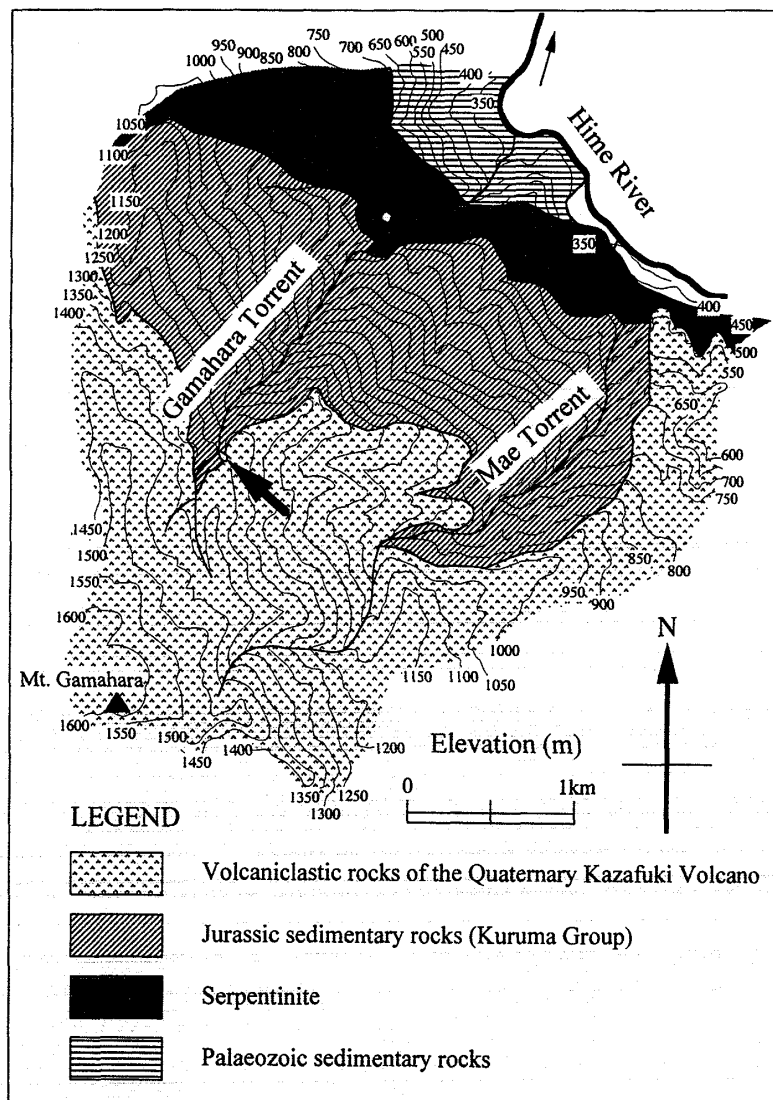
Fig. 4. Geologic map around the Gamahara Torrent (Partially simplified after Shiraishi, 1992). The arrow shows the slope failure in the upper area.

ascending order, Paleozoic sediments, serpentinite, the Jurassic Kuruma group, and Quarternary Kazafuki volcanics [2]. The Paleozoic sediments consists of sandstone, shale, and chert. The Kuruma group consists of sandstone, mud stone, and conglomerate. Fig. 4 shows the geological overview around the Gamahara Torrent watershed. Serpentinite is distributed in the lower part of the watershed and the Kuruma group in the middle part. The upper part of the watershed is covered with Kazafuki volcanics. The Kuruma group has a strike of E-W or NE-SW and dips 40–70 degrees to the south. The left slope of the Gamahara Torrent almost parallels the geological stratification and the right slope is diagonal to its. In general the watershed has a cuesta structure produced by the shape of the Kuruma formation.

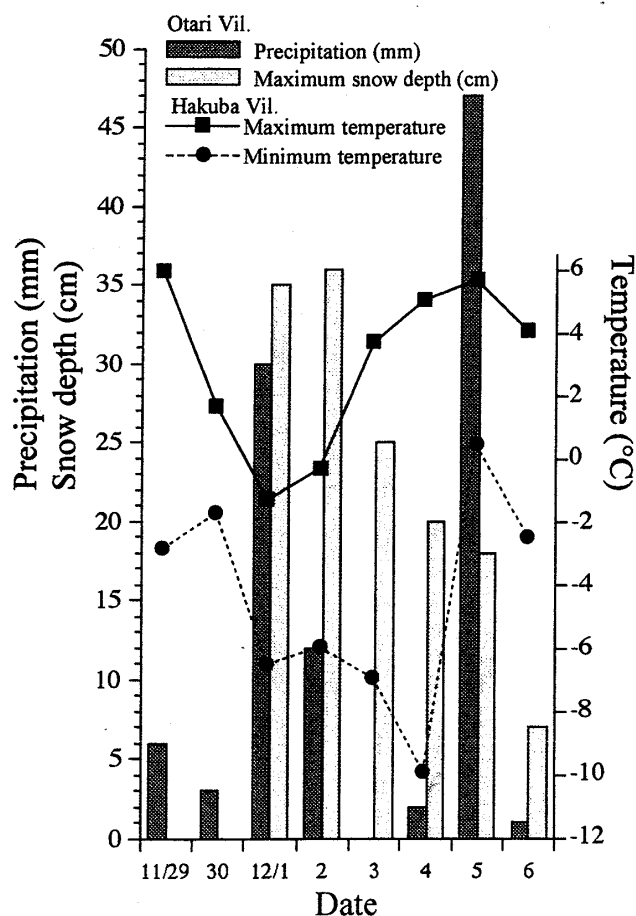
In terms of the triggering of the water supply, there are two types of debris flows in the tributaries of the Hime River. Debris flows caused by heavy rainfall in summer and those caused by snow melting in early spring. The debris flow on 6 December 1996 occurred during a dry season in which debris flows very seldom take place. Fig. 5 shows the weather conditions recorded by the nearest meteorological stations in Otari Village and Hakuba Village prior to the debris flow. On 6 December there was almost no rainfall and during the previous day only 47mm rainfall had been recorded. Furthermore, on 1 December a snow cover depth of 35cm was recorded. On 5 December the minimum temperature had risen suddenly, more than 10 degrees, and was higher than zero degree

Fig. 5. Weather conditions preceding the debris flow (after values measured with AMEDAS by the Nagano district weather station).

Celsius. The measured snow cover depth decreased from 18 to 6cm during that day. The amount of snow melt water is estimated to have been at most about 24mm as based on the decrease in the snow cover depth, assuming that the mean density of the snow layer was nearly 0.2 g/cm^3 . The total amount of the water supply therefore should have been about 70 mm, including the 47mm rainfall.

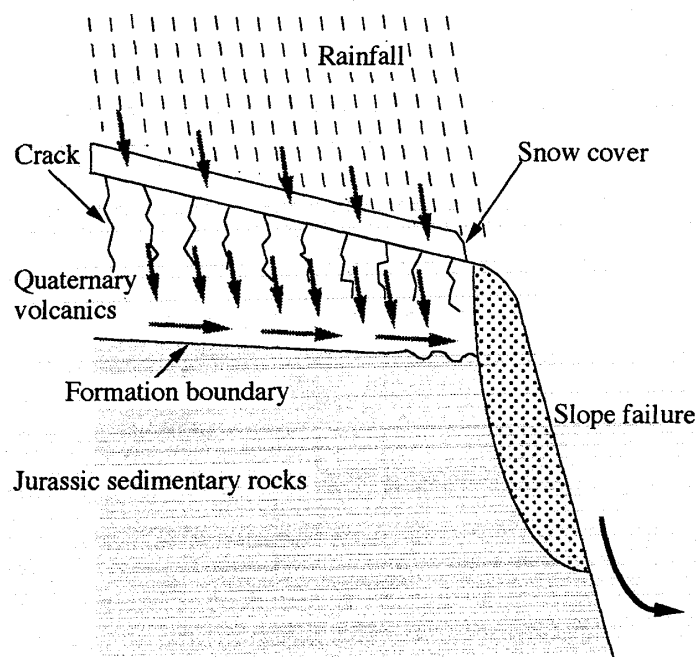
Fig. 6. Schematic model of the slope failure which triggered the debris flow.

The slope failure occurred in the upper part of a very steep slope failure scar that was caused by extremely heavy rainfall on 11 July 1995. The failure is located at the topographical knick point and the geological formation border between the Quaternary Kazafuki volcanics and the Jurassic Kuruma group. There are many joints and fissures in the upper soil layer of the Quaternary Kazafuki volcanics so that the layer has a high infiltration rate. The lower soil layer of the Jurassic Kuruma group has a low infiltration rate. Water from rainfall and snow melt therefore could easily infiltrate the upper soil layer, reach the geological formation boundary, then be discharged along the boundary to the slope surface (Fig. 6). The slope failure should have been triggered by this type of discharged water.

The probable explanation is that rainfall and snow melt water infiltrated the porous Kazafuki volcanics, pushing out groundwater along the boundary between the Kazafuki volcanics and the impermeable Kuruma formation. The groundwater stored in the Kazafuki volcanics was discharged into the debris deposits on the torrent bed. The debris flow therefore contained this stored water and brought it downstream. Geological structure composed of two different strata easily could cause a slope failure at this geological boundary.

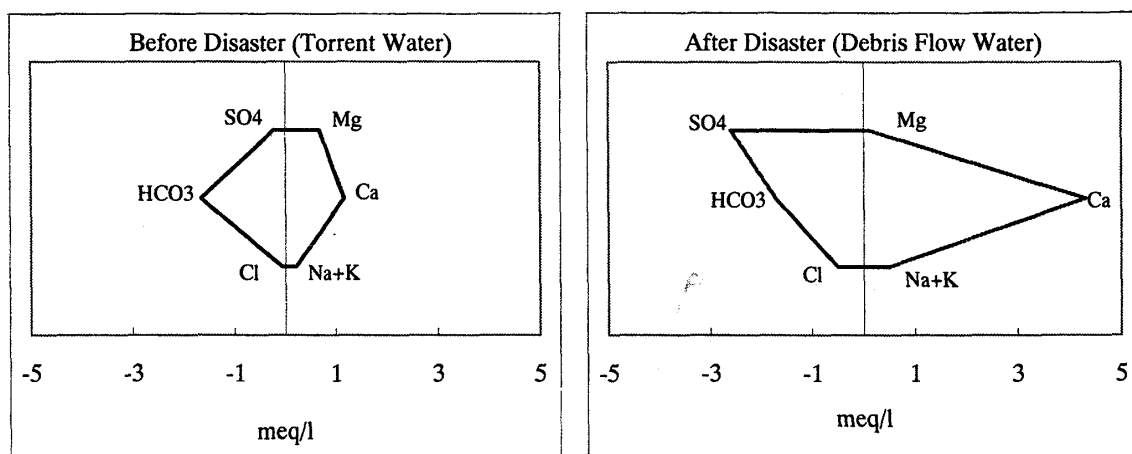
Fig. 7. Pattern diagrams of the major ions in the torrent and debris flow waters.

in the altered volcanic materials in this area. The high EC value suggests that the water in the debris flow did not originate from rainfall and snow melt which have low EC values, but from groundwater which has a high EC value.

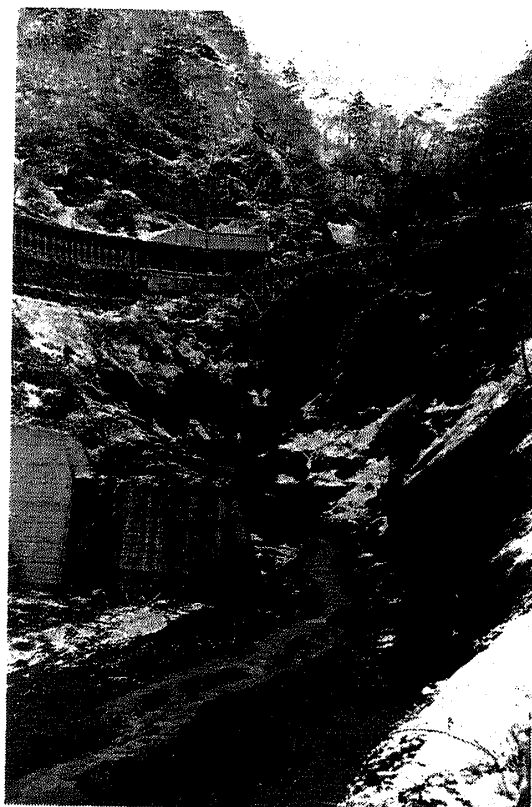
On 6 December 1996, a debris flow occurred in the Gamahara Torrent in Otari Village, at the border between Niigata and Nagano Prefectures, Japan (Fig. 1). Fourteen workers were killed and eight injured, after being caught in the deluge of mud, sand and rocks by the debris flow that hit the torrent control dam construction site near the confluence of the Hime River as well as at another site about 1 km upstream. Photo 1 shows the slit-type torrent control dam near the confluence. The highest part of the debris flow passed over the crown of the dam. Photo 2

Photo. 1. Torrent control dam near the confluence with the Hime River (after the passage of the debris flow)

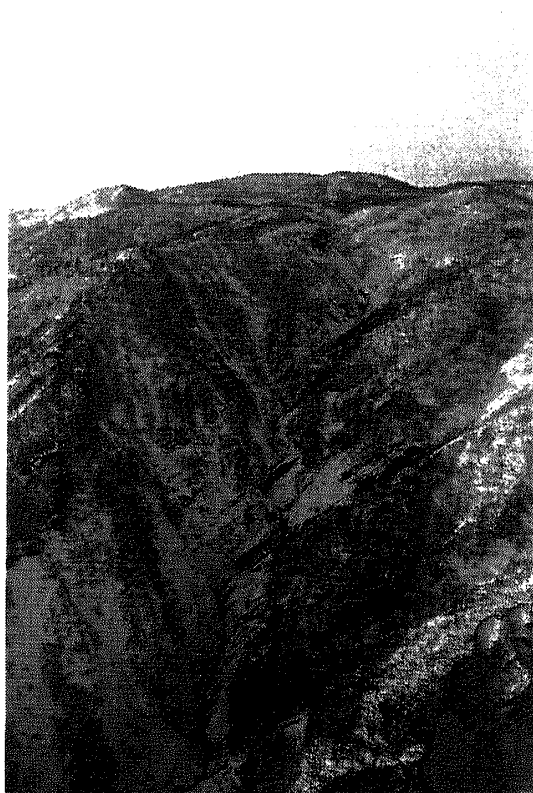
Aerial observation suggests that the debris flow was triggered by slope failure at the elevation of about 1,300m (marked in Figs. 3 and 4). Photo 3 shows a distant view of the triggering slope failure and traces of the debris flow. Photo 4 shows a near view of the same slope failure. At first the volume of the slope failure was estimated to be at most 5~6 thousand m^3 from simple optical aerial observations. Later it was estimated to be 33,000 m^3 by aerial photo interpretation [1]. Probably, this slope failure material fell down the slope to the torrent bed, struck torrent deposits saturated with water, and

Photo. 3. Distant view of the triggering slope failure and the trace of the debris flow.

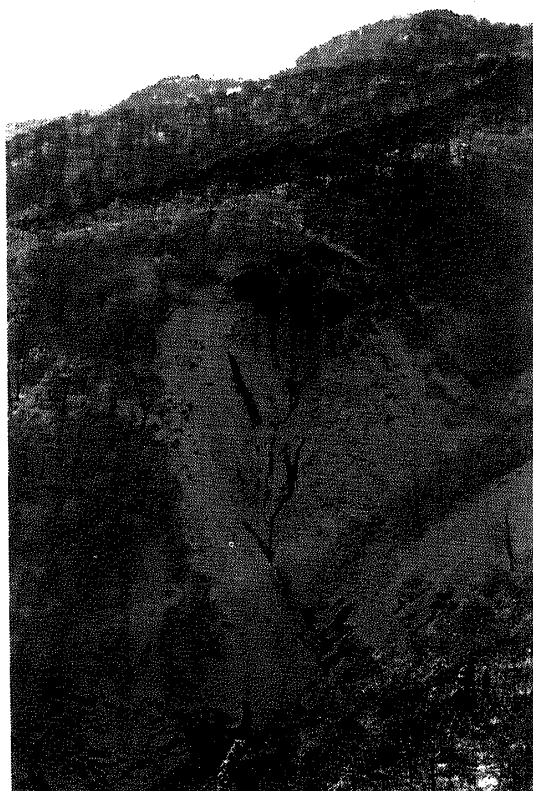
Photo. 4. Near view of the same slope failure in Photo 3.
