地形 第33巻第4号 365-384頁 (2012)

Two Distinguished Effects of the 2011 Great Tsunami to the Coasts along Sendai Bay: Damage to Arahama and Trench Formation behind the Dike on Yamamoto Coast

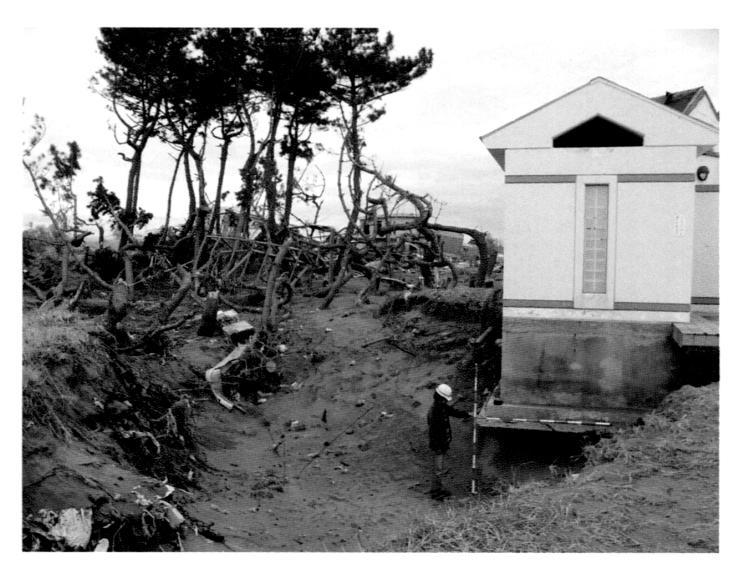
Figure 5 shows a large scouring hole formed at the south corner of a restroom for public use located at the entrance to the beach seaward of point A in Fig. 3. At the corner of the building, a large scouring hole of 3 m depth, directed slightly northward, was formed, and the depth showed its maximum at the corner of the building and gradually decreased landward. In the vicinity of this hole, sand was not deposited,

implying that sand was transported further landward by tsunami currents.

Fig. 5. A large scouring hole formed at the south corner of a restroom for public use.

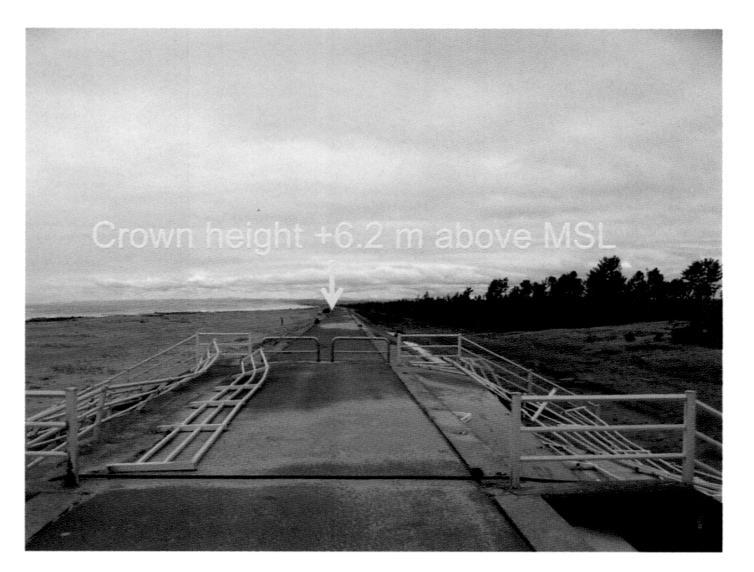
Figure 6 shows the crown of the coastal dike with an elevation of +6.2 m above MSL, facing south. The steel fence on the crown fell down landward, suggesting the generation of strong tsunami currents. Although tsunami currents flooded over the dike, the entire breakdown of the coastal dike did not occur and the back slope of the dike retained its original shape. Even though the residential area near point A was protected by the coastal dike, the houses were entirely destroyed by the tsunami. Figure 7 shows the damage to houses, facing south. The houses were completely destroyed except for their foundations.

Fig. 6. Concrete coastal dike with crown height of +6.2 m protecting seaward side of residential area.

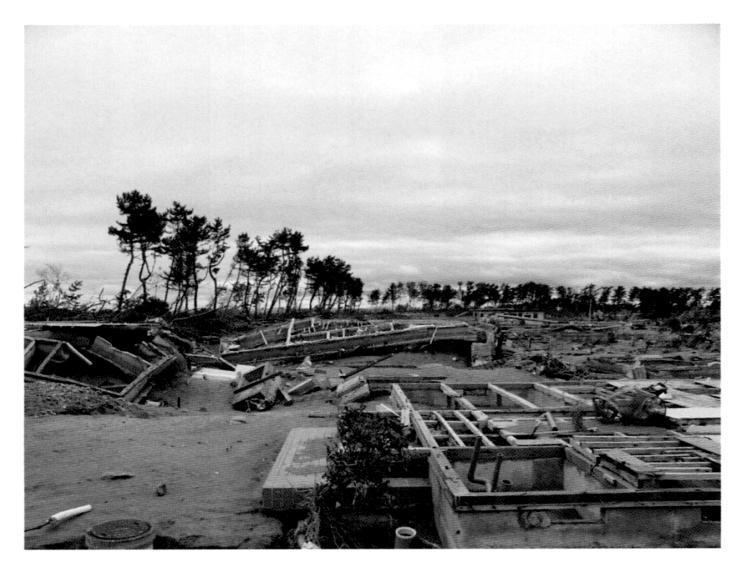
Fig. 7. Damage to houses.

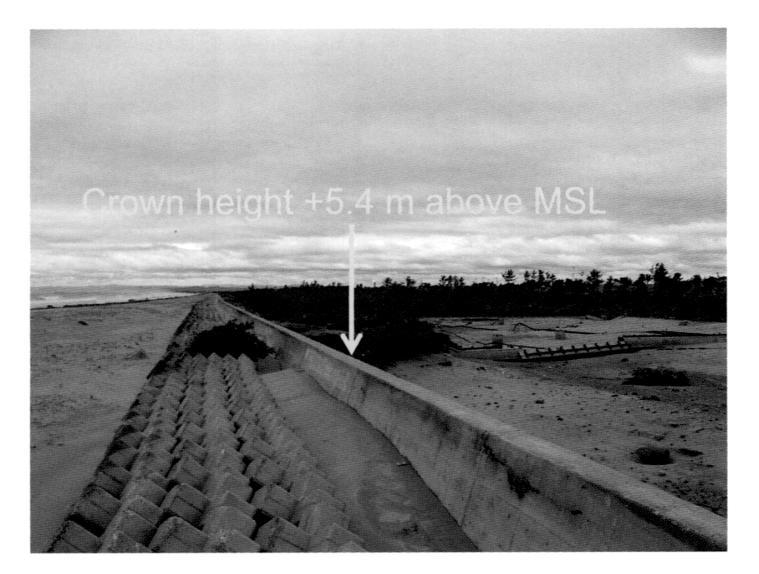
crown height of +6.2 m, as shown in Fig. 6. However, the crown height of this coastal dike decreased to +5.4 m above MSL, 0.8 m lower than that of the coastal dike in the north part, at the south end of the residential area, and its structure also altered from a coastal dike with a trapezoidal cross-section to a vertical seawall, as shown in Fig. 8. This allowed easy overflow of the tsunami. There was a gap between the vertical seawall in the south part and the coastal dike in the north part, and the tsunami was concentrated at this gap. A large scouring hole was formed around this gap, where the original ground was eroded at the corner, as shown in Fig. 9, implying the generation of strong tsunami currents. The arrow in Fig. 9 shows the direction of expected tsunami currents around the corner.

Fig. 8. Vertical seawall with lower crown height.

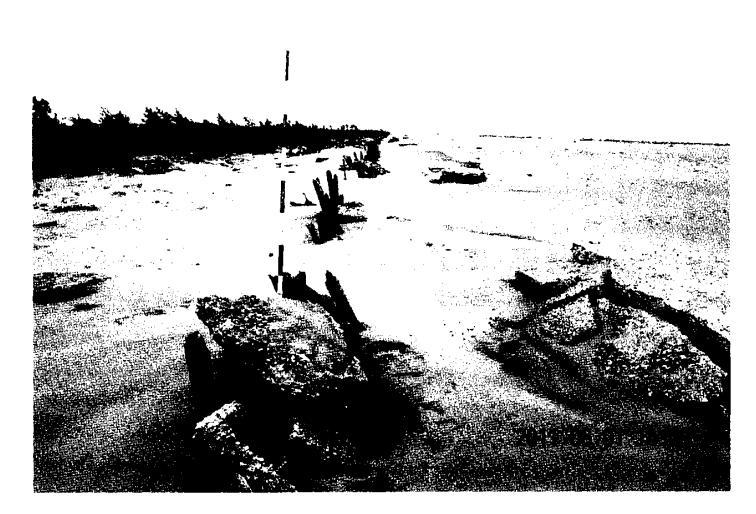
Fig. 12. Destroyed wooden fence preventing wind-blown sand at the north of channel.

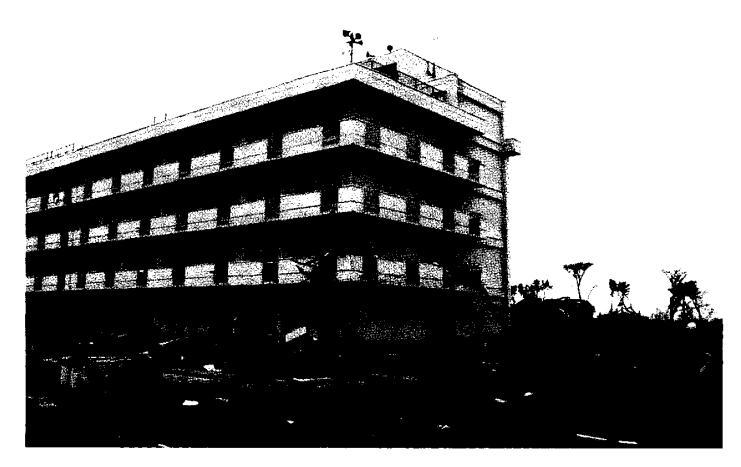
Fig. 13. Damaged Arahama elementary school.

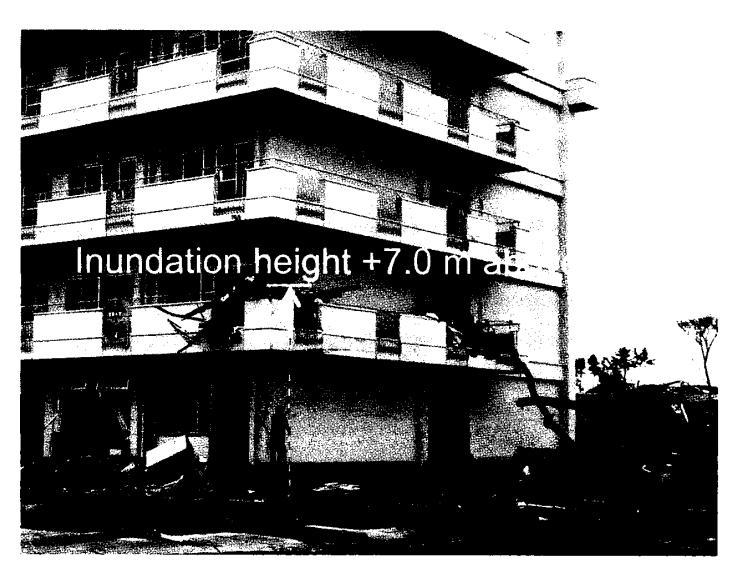
second floor was also inundated, as shown in Fig. 13. Figure 14 shows the condition of the south side of the school building. A large amount of driftwood was deposited on the south side of the second floor of the building. The elevation of the upper limit of the driftwood was +5.5 m above the ground level. Because the ground elevation around the school was +1.5 m above MSL, the tsunami inundated the building up to a level that was +7 m above MSL. Figure 15 shows the debris accumulated in a corridor of the school building. At the end of the corridor of the first floor, the deposited debris reached the ceiling, and a long pine tree and a car were transported into the corridor.

Fig. 14. Condition of the south side of school building.

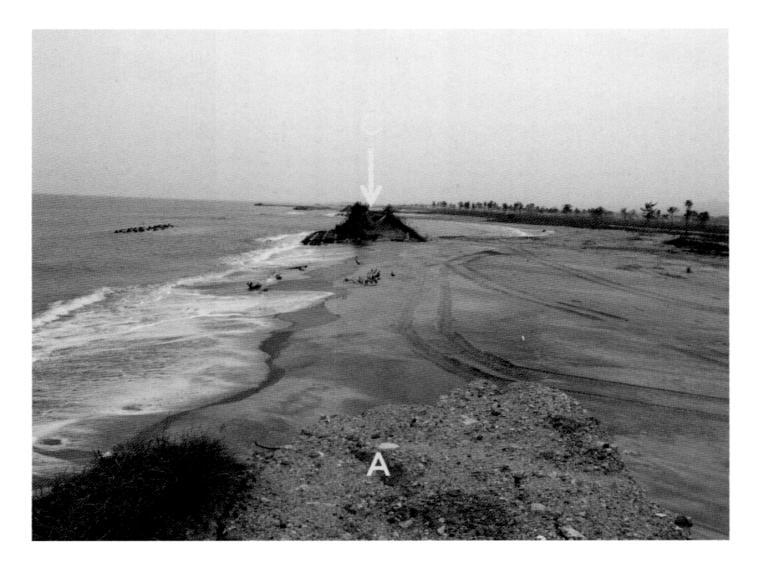
Figure 19 shows a part of the destroyed coastal dike, facing south from point A shown in Fig. 18. At a location 100 m south of point A, the remains of the coastal dike were observed and the sandy beach extended between points A and C. Sand deposition was not observed near point C in April, 2011, as shown in Fig. 18, although a cuspate foreland was formed near point A. This implies that a large amount of sand was transported and deposited by wave action during the period between April, 2011 and August 12, 2011.

Fig. 19. Part of destroyed coastal dike.

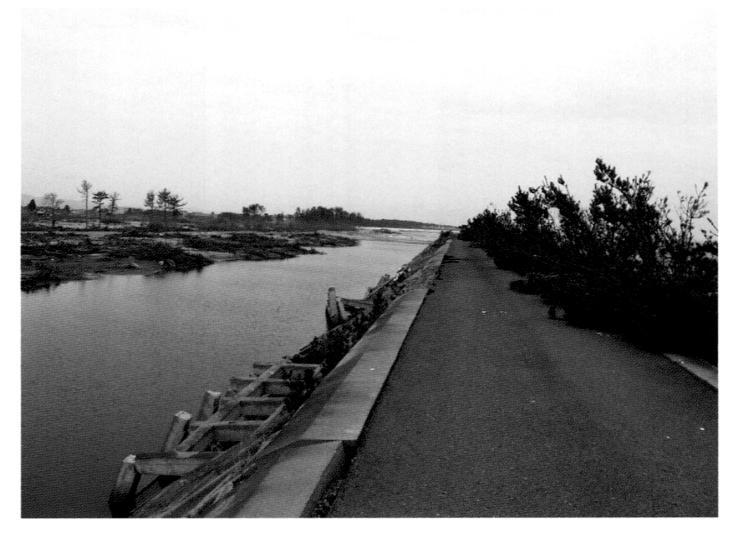
Figure 20 shows the coastal dike and a trench north of point A. There was no deformation in the asphalt pavement of the crown, although pine trees planted on the seaward slope of the dike were uprooted. In contrast, the back slope of the concrete dike was severely destroyed, and a trench of approximately 50 m width was formed inland of the destroyed back slope. The failure of the back slope was considered to be due to the local scouring at the toe of the back slope and the suction of the sediment that filled the dike when the tsunami flooded over the dike. Figure 21 shows the damage to the crown in an area further north. The back slope, as well as the asphalt pavement, was much more severely damaged than that in the south part. Approaching the north end of the coastal dike (point B in Fig. 18), the coastal dike was severely destroyed and almost the entire crown of the dike fell down (Fig. 22).

Fig. 20. Crown of coastal dike north of point A.

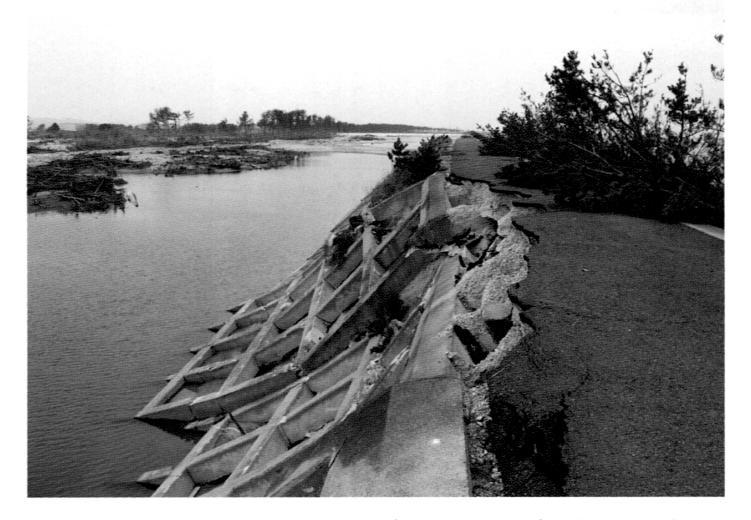
Fig. 21. Damage to crown in the area further north.

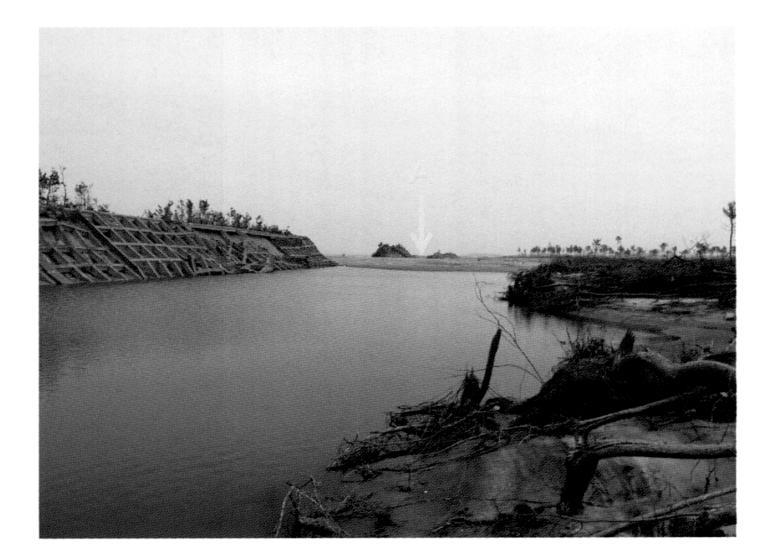
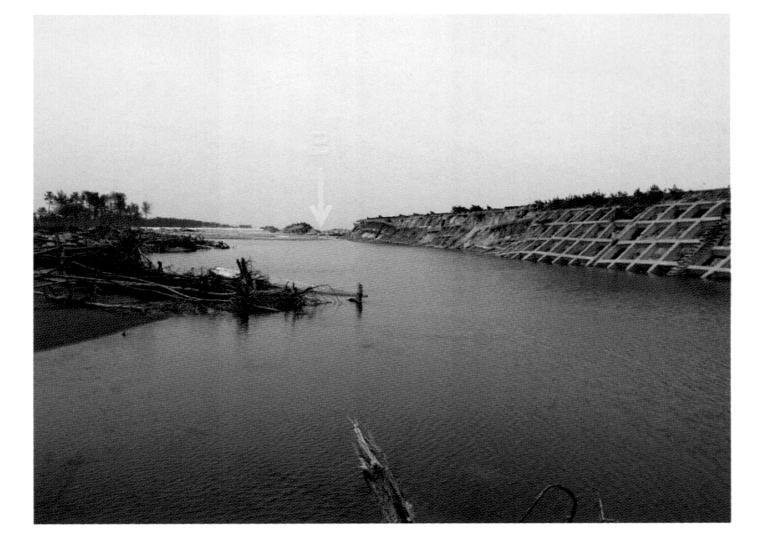
The Yamamoto coast was severely eroded even before the tsunami, there were no sandy beaches, and the coastline was protected by a concrete coastal dike and concrete armor units. In this area, the coastal dike was severely destroyed. Figures 25 and 26 show photographs of the trench uniformly formed alongshore behind the dike, which were obtained looking south and north, respectively. Most of the back slope was destroyed by the tsunami and slid down. In addition, the subsidence of the back slope also occurred due to the discharge of earth materials that filled the dike. It is considered that because the trench was continuously formed alongshore, the scouring occurred two-dimensionally.

Fig. 25. Photograph of trench uniformly formed alongshore behind coastal dike (south).

Fig. 26. Photograph of trench uniformly formed alongshore behind coastal dike (north).

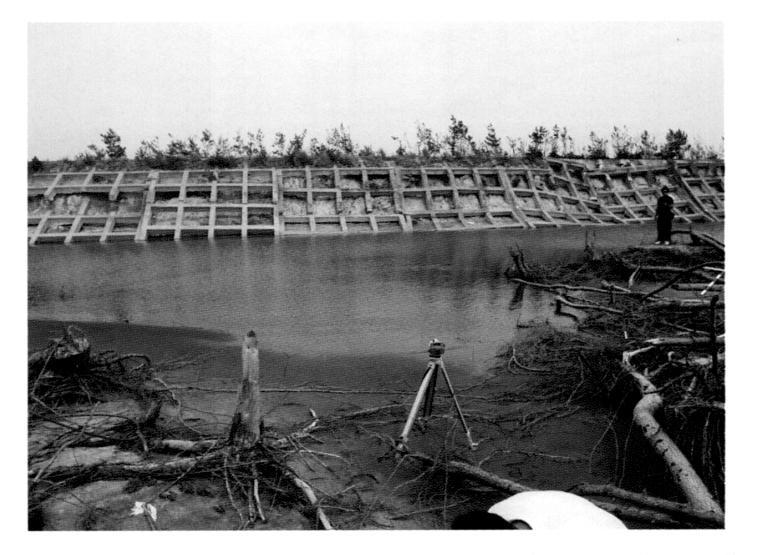
Across the trench formed inland of the damaged dike, as shown in Fig. 27, where sand deposition did not occur, the cross-shore profile (Fig. 28) was measured across the trench. The width and depth of this channel at the ground level were 50 m and 2 m, respectively.

Regarding the back slope shown in Fig. 27, sediment that filled the dike was discharged and the concrete slab was broken. Such condition can be clearly realized in Fig. 29, in which the concrete frames were broken and left in the air due to the

Fig. 27. Trench formation and back slope of damaged seawall.

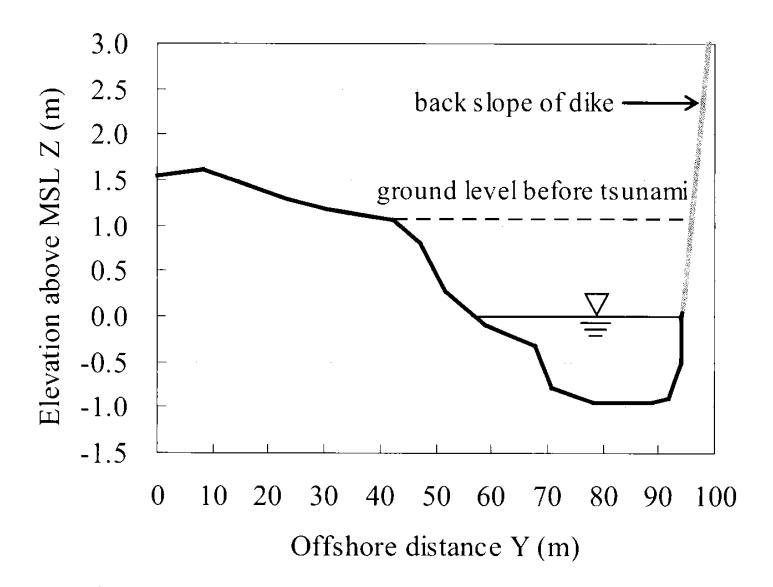
Fig. 28. Cross-shore profile measured across trench.

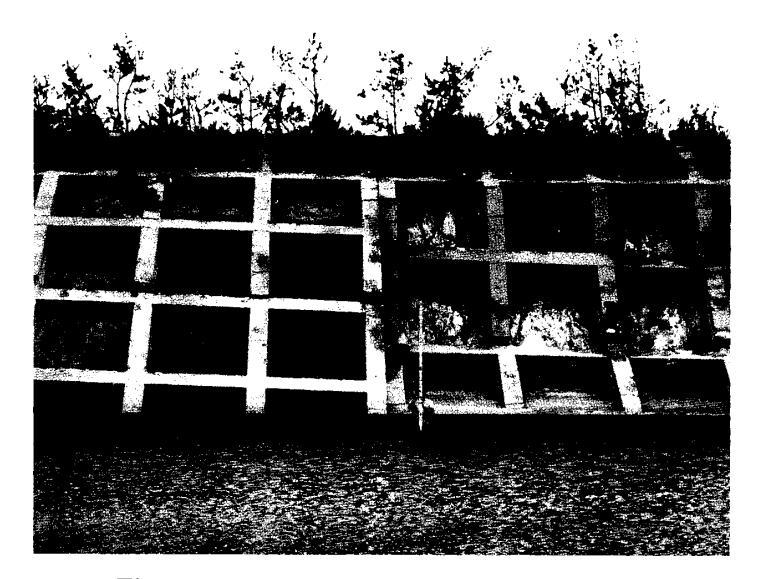
Fig. 29. Back slope of damaged coastal dike.

scouring. Taking the development of the trench behind the partly destroyed dike into account, it is concluded that the ground level rapidly decreased near the toe of the back slope, forming openings beneath the toe of the back slope. Sediment was discharged through these openings, and finally the back slope was destroyed.

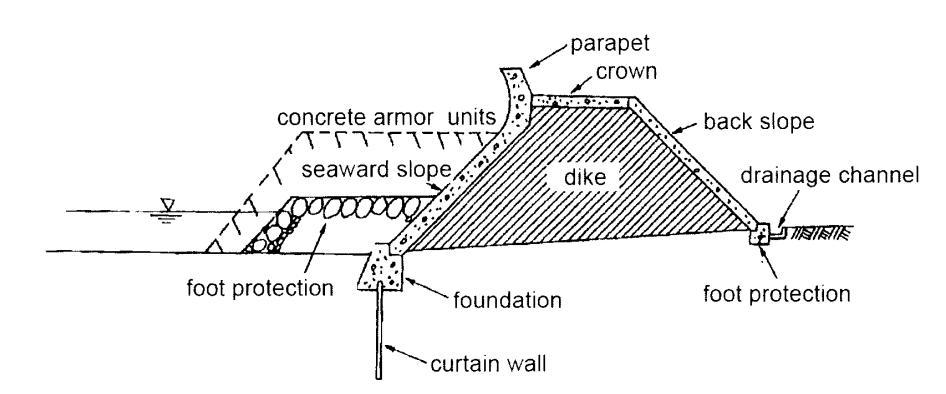
Fig. 30. Typical cross section of coastal dike based on Japanese shore protection manual.

and the back slope must be protected using concrete, as indicated in the Japanese design manual. However, regarding the back slope, there was no suggestion that large scouring would occur at the toe of the back slope. Thus, the back slope became a weak point of the structure against local scouring behind the dike during a tsunami having the height of which exceeded the crown height.
