# Trends of Recent Hull Damage and Countermeasures

by Tomoo Mizukami<sup>\*</sup>, Ichiro Ishikawa<sup>\*\*</sup> and Michifumi Yuasa<sup>\*\*\*</sup>

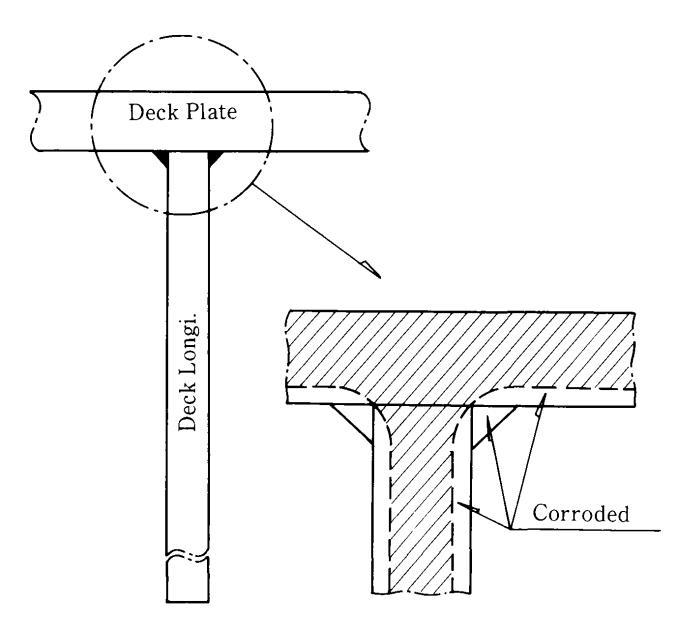
When an oil tanker ages, it is common for wastage of the deckhead of the upper deck in cargo oil tanks and ballast tanks to have developed to a considerable extent. Although sufficient attention tends to be given to the wastage of structural members such as deck transverses and deck longitudinals, wastage of fillet welds tends to be overlooked. We have often experienced failures involving several metres of longitudinals which have detached due to a reduction of the effective throat thickness of fillet welds of upper deck longitudinals (see Fig. 5).

Fig. 5 An example of wasted deck longitudinal

experienced a serious hull failure involving the buckling of the upper deck plating amidships with consequent bending of the hull, which was partly due to improper loading, while proceeding under ballast on a relatively calm sea.

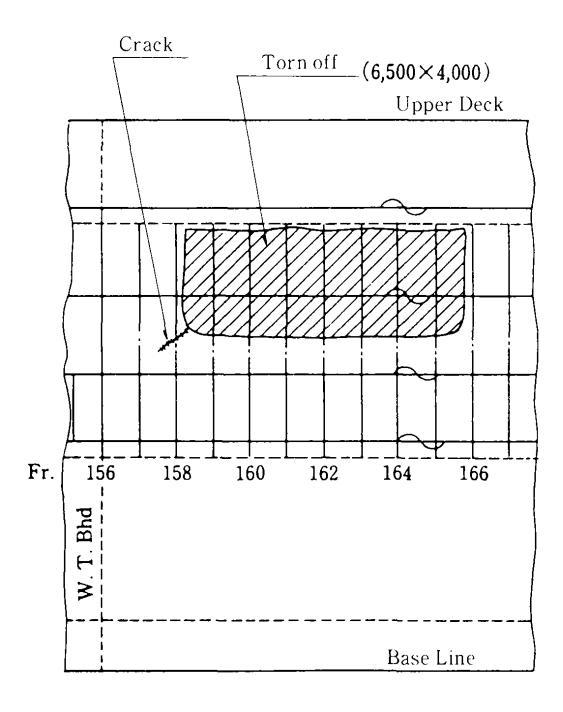
Failures are concentrated on bulk carriers, and failures of the side shell plating, in many cases, occurred in plating in way of cargo holds, while they were at sea laden with iron ore. In some cases, part of side shell plating with side longitudinals became detached and fell off. Fig. 6 shows the condition of a 14 years old large bulk carrier whose side shell plating had fallen off.

Fig. 6 Damage of side shell of cargo hold (bulk carrier)

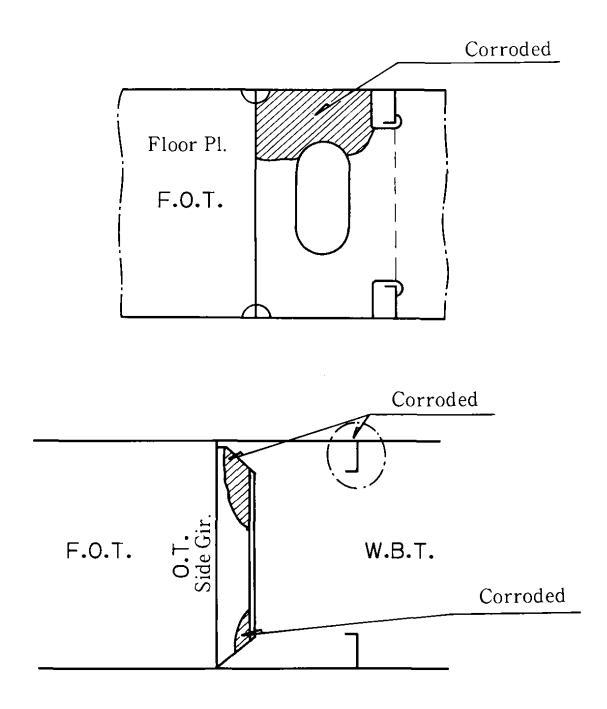
In compartments adjacent to fuel oil tanks with heating coils, additional precautions are necessary as the corrosive environment deteriorates under the effects of high temperatures. Care must be taken in this regard<sup>10</sup> With the transverse bulkhead within the top side tank bounding the fuel oil tank, we have experienced a fracture opening created when the ship was aged 10 with the thickness of the surrounding plates reduced to less than 50% of the original thickness over an extensive area. If such

Fig. 7 Corrosion and wastage in the vicinity of side girders in double bottom (boundary wall of FOT and WBT)

conditions of wastage are left unnoticed, fracture openings and crackings are produced resulting in oil spill accidents, hence, early detection and maintenance are necessary. Similar problems can occur with double bottom ballast tanks, and corrosion and wastage often occur particularly in the double bottom tank of a general cargo ship. Fig. 7 shows examples of failure shown above.

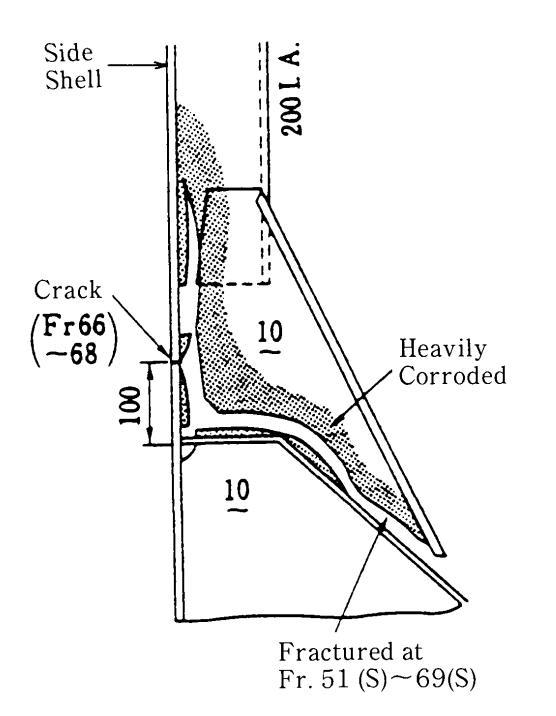
Fig. 8 Crack damage of side shell due to wastage and fracture of lower end brackets of hold frames

frames as in (2) above, some others were caused by grooving corrosion developing along frame lines due to corrosion fatigue under the reduced strength of worn shell plating and wave loads, with cracking and/or fracture openings eventually occurring in many cases. Fig. 8 shows an example of such failures.

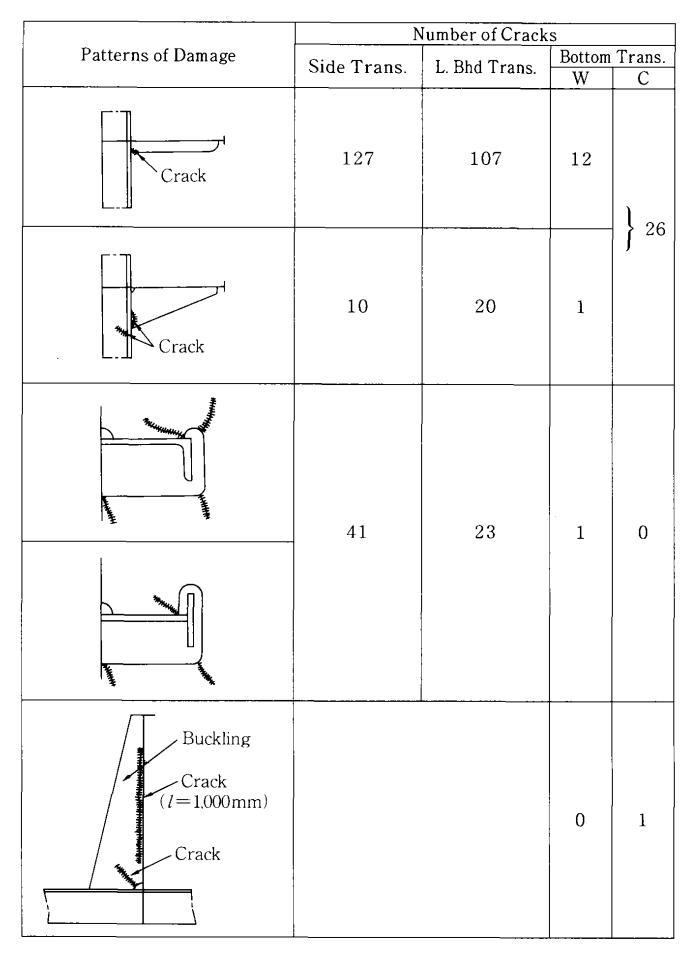
In first generation VLCCs built in a huge tonnage during the period from the second half of the 1960's to the 1970's, many cracks were generated in transverses and stiffeners on the transverse bulkheads of cargo oil tanks and water ballast tanks at relatively early periods of their services. Examples of typical failures are shown in Fig. 9.

Most of these failures were identified as cracks in the peripheral areas of slots in girder webs and cracks in the connected parts between flat bars on web plates and longitudinals. Concerning cracks in connections to longitudinals, cracking in the longitudinals themselves was rare. The results of an investigation on failures of structural hull members in large oil tankers from 1973 to 1979 show that failures were predominant in bottom transverses, girders on transverse bulkheads, girders on longitudinal bulkheads and side transverses, but there were not many failures of side longitudinals.

Fig.9 An example of crack damage frequently occured in large oil tankers of 1970's

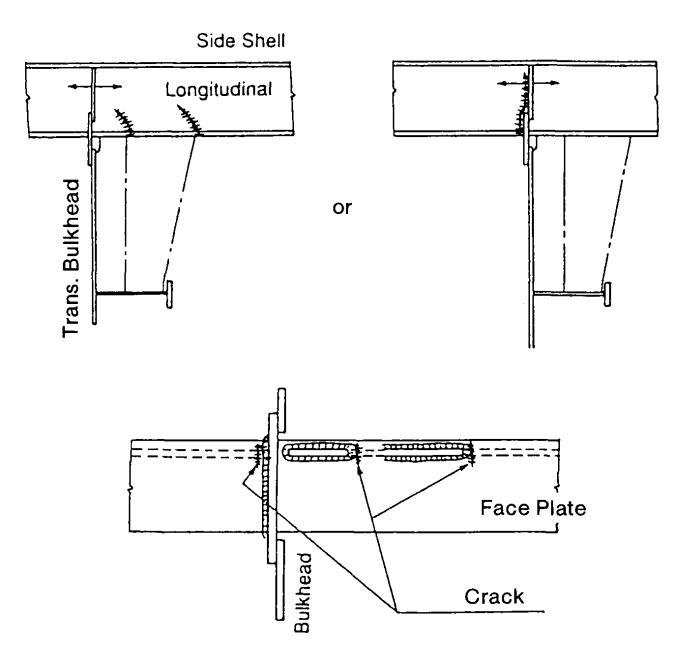
In second-generation VLCCs, use of high tensile steels greatly increased so they were used even for side longitudinals. As a result, the number of ships suffering from cracking of side longitudinals in the three to four years after delivery increased. Fig. 10 shows the typical examples of cracking failures.

Many cracks were found in the collars of transverse bulkheads or heels of flat bars or bracket on web plates where side longitudinals penetrate transverse bulkheads or side transverses. Based on the results of a meeting to assess high tensile steel structures provided for studying countermeasures<sup>11)</sup>, the locations of failures are shown in Fig. 11.

Fig. 10 Examples of crack damage of side longitudinals

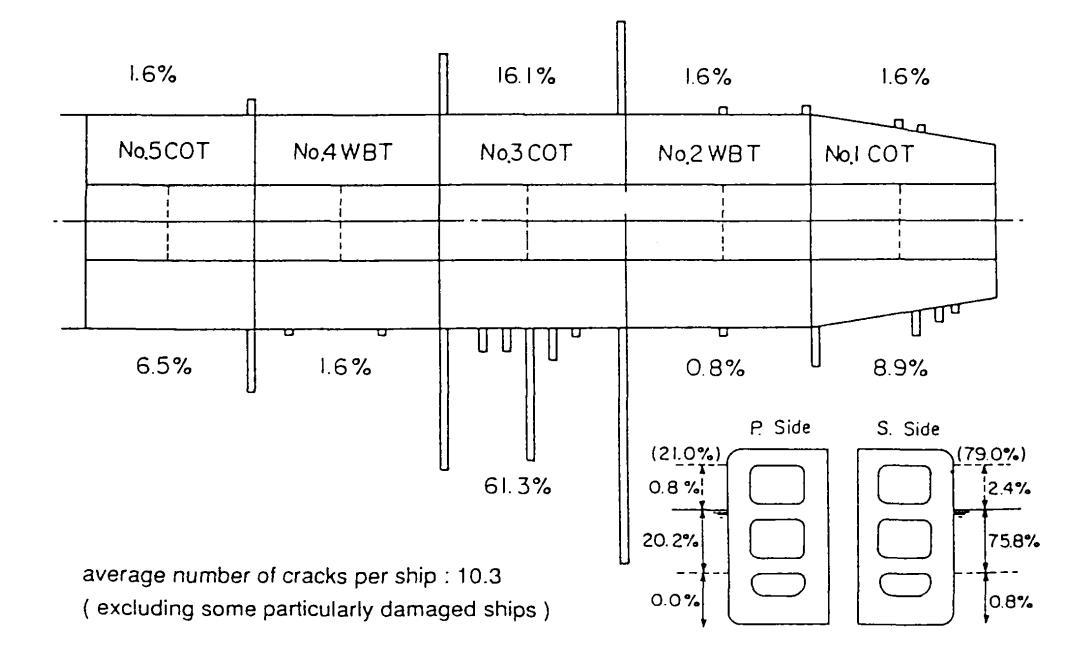
Fig. 11 Distribution of damage in VLCC's of second generation

- Failures are most significant in No. 3 C.O.T., which is close amidships.
- Failures are more significant in transverse bulkheads afore or abaft tanks.
- Depthwise distribution of the locations of failures shows they heavily concentrate in the area from the water line to seven metres therebelow.

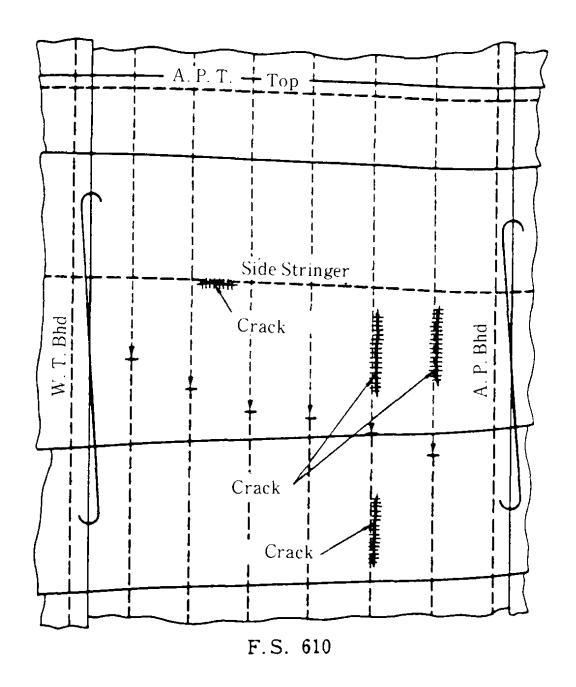
- Cracks in shell plating due to vibrations Due to impacts of propeller-induced vortex wake, the shell plating in the aft part of a ship:
  - i) undergoes panel vibrations with consequent cracks running along the fitting lines of frames or floors. Many were found in container carriers and pure car carriers with a wide and flat stern

Fig. 12 An example of crack damage of shell plate due to vibration

construction. Examples of cracks are shown in Fig.  $12^{12}$ .

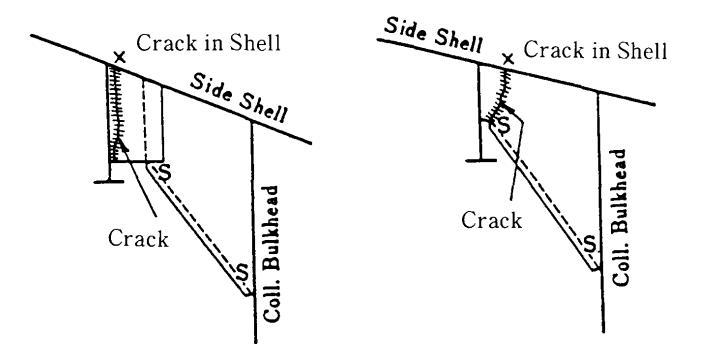
- (2) Cracking of internal members propagating to shell plating
  - In general cargo ships and bulk carriers, the ratios of occurrences of fatigue cracks due to stress concentration are high in the balance bracket at the fwd end corners in No. 1 cargo hold or the fwd end brackets of side longitudinal web penetrating the side frames, and the lower end brackets of hold frames, and these cracks often propagate to the shell plating. Examples of failures of balance brackets caused by defective geometric shapes are shown in Fig.  $13^{13}$ .

Fig. 13 Crack damage of fore end balancing bracket of cargo hold

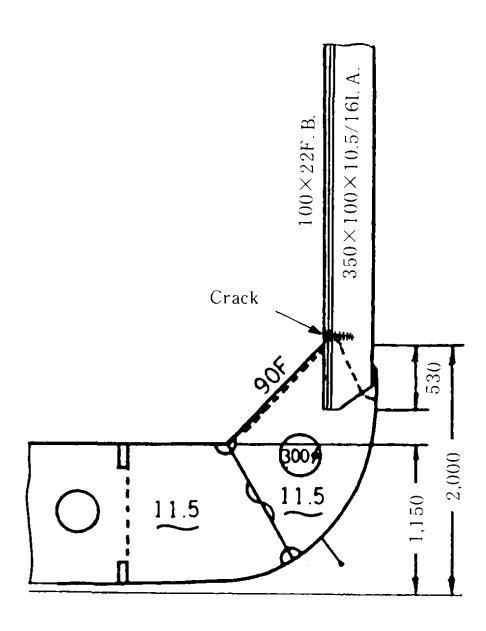
There are many failures due to inadequate fabrication of slant plates on brackets. Cracks propagated from similar members to the shell plating at the corners of common cargo/ballast holds of bulk carriers and chip carriers are not few. The stress levels at connections between hold frames and lower end brackets are high with a high stress concentration caused by their geometry, and fatigue cracks in them are relatively frequent. Examples of fatigue cracks are shown in Fig. 14.

Fig. 14 Crack damage of lower end bracket of hold frame

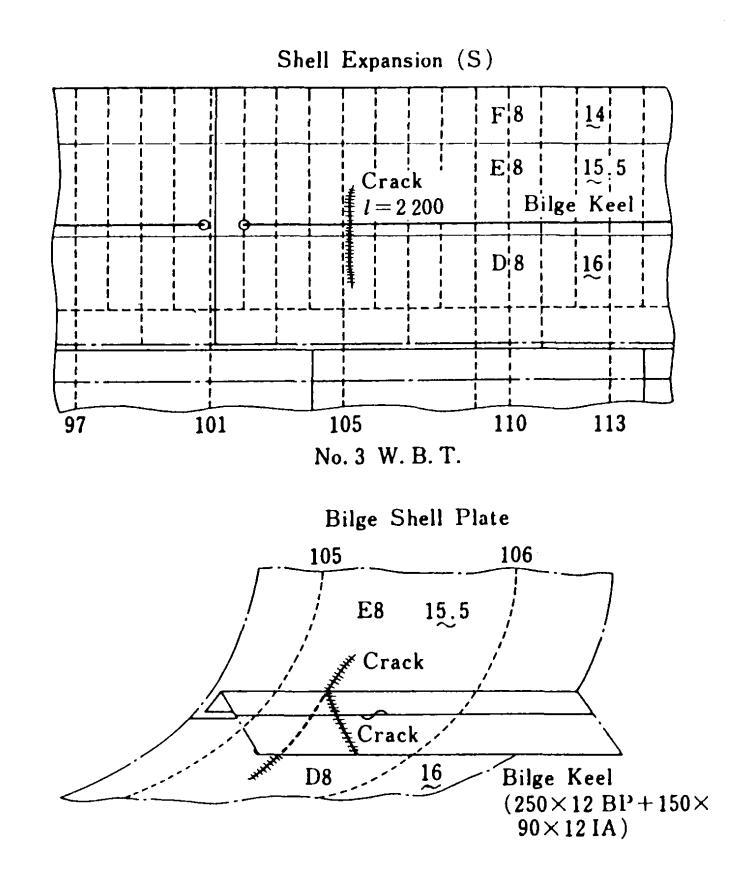
Fig. 15 Crack damage of shell plate through joint of bilge keel

which are directly fitted to the shell plating, the same precautions must be taken for butt welds of secondary members and bilge keels. Fig. 15 shows a case of a 2.2 *metre*-long crack generated in the shell plating because of a poorly welded bilge keel during replacement work, which was bent as the consequence of a marine casualty<sup>14</sup>.

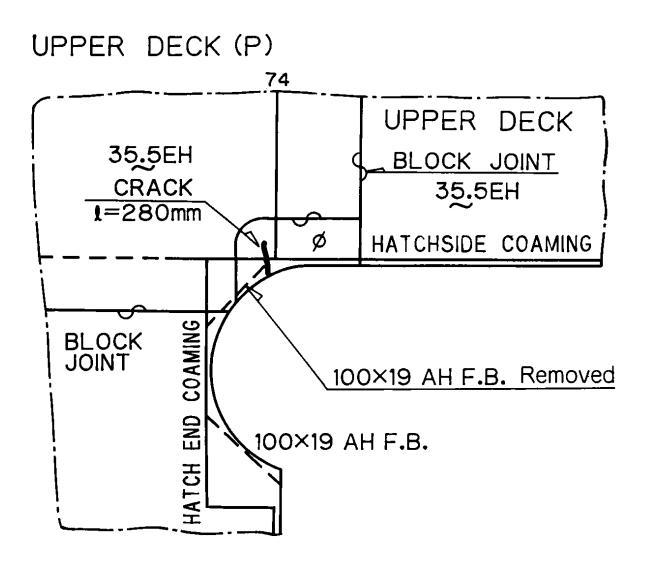
Fig. 16 Crack damage at hatch corner (container carrier)

hatch corners of a container carrier<sup>15)</sup>. The origin of the crack is located at the end of a flat bar for preventing buckling provided at the corner. In the absence of a danger of buckling at the corner, the flat bar in question was removed during repair work. In one case,

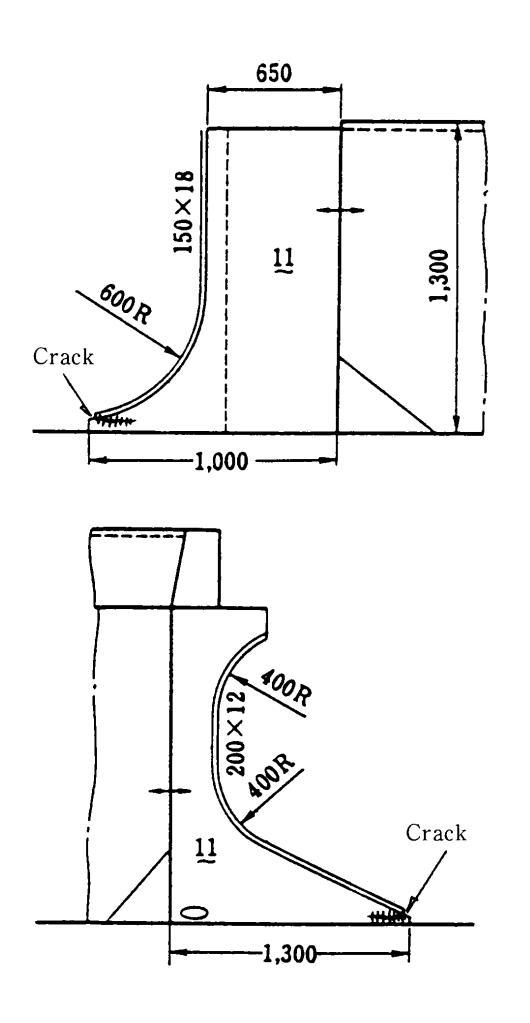
Fig. 17 Crack damage of end bracket toe of hatchside coaming

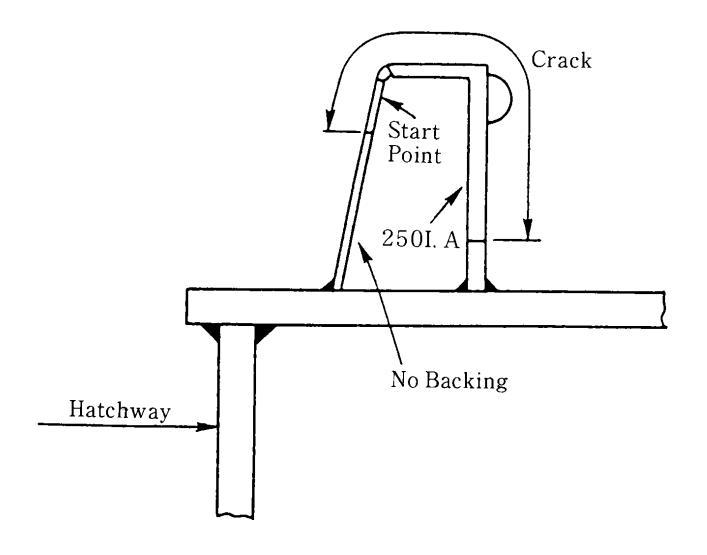
Fig. 18 An example of brittle fracture by hatchside coaming top

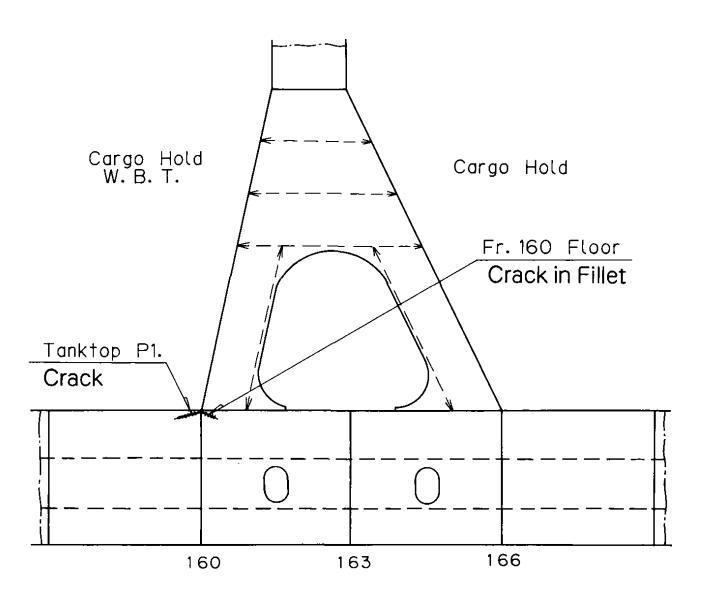
Fig. 19 Crack damage of lower part of trans. bulkhead stool (bulk carrier)

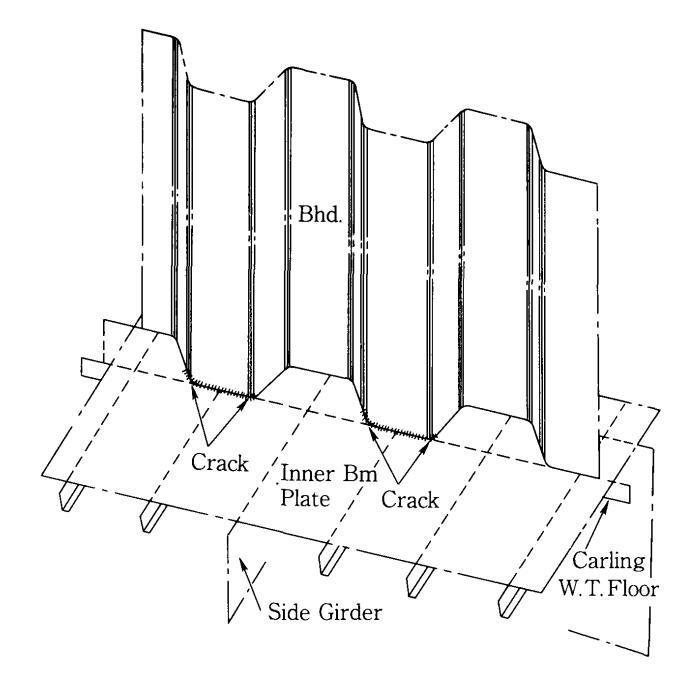
Fig. 20 Crack damage of lower part of corrugated trans. bulkhead (chip carrier)

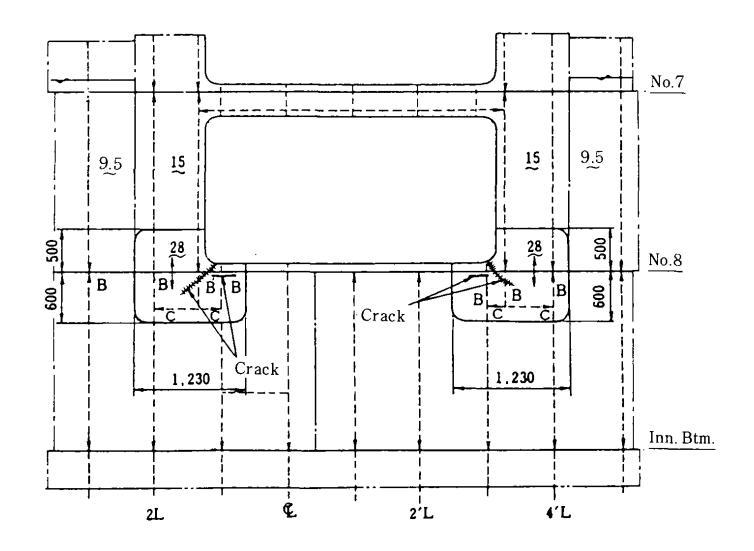
Fig. 21 Crack damage at corners of trans. bulkhead opening (car carrier)

hull are frequent. Shown in Fig. 21 are examples of cracking failures generated at the corners of large openings provided in the transverse bulkheads for the passage of cars<sup>15)</sup>.

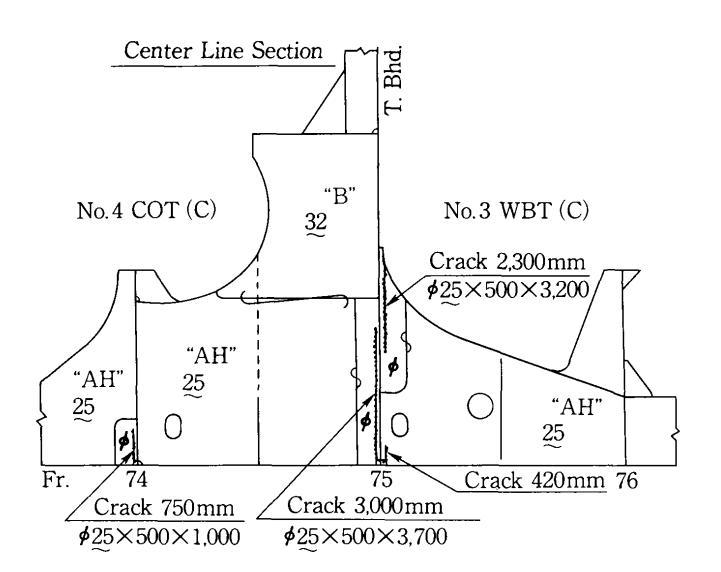
In the example shown in Fig. 22, cracks in the connected part between longitudinal bottom centre girder and the transverse bulkhead at the boundary between No. 3 W.B.T.(C) and No. 4 C.O.T.(C) were found just before fracturing. It is considered in this way that fatigue cracking had developed due to cycled high stresses under the joint effects of longitudinal bending stress, longitudinal shearing stress and local bending stress caused by ballast. In

Fig. 22 Crack damage of bottom center-line girder (oil tanker)

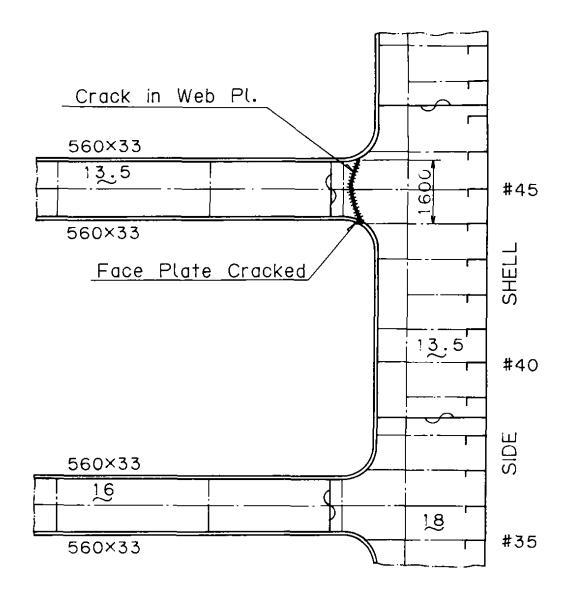
Fig. 23 Crack damage of cross tie of trans. girders (oil tanker)

the example shown in Fig. 23, the cracks in the upper cross ties on the shell side were found in four transverse rings of No. 3 C. O. T. (S) in a condition just before being fractured.

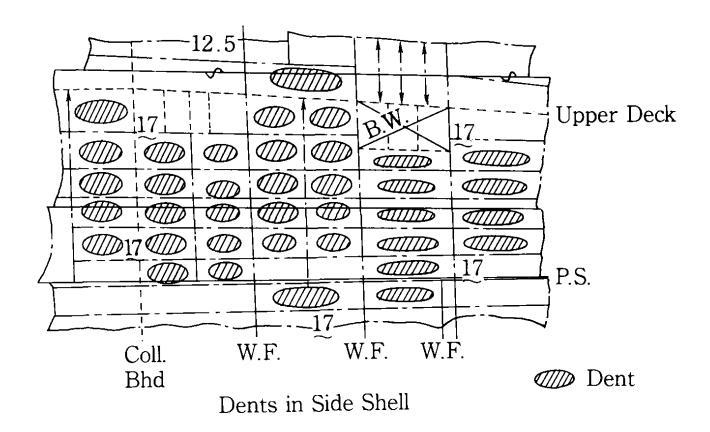
In high-speed container carriers with large flares at the bow, failures are experienced in the sides forward caused by wave impacts. Most of such failures are concentrated in the upper space of F.P.T. and side structures located aft of it. The extents of failure range from a slight dent in the shell panel to buckling

Fig. 24 Deformation damage of fore side shell (container carrier)

of web plates of strong frame , and bending of frames. Fig. 24 shows the examples of failures in container carriers<sup>17</sup>.

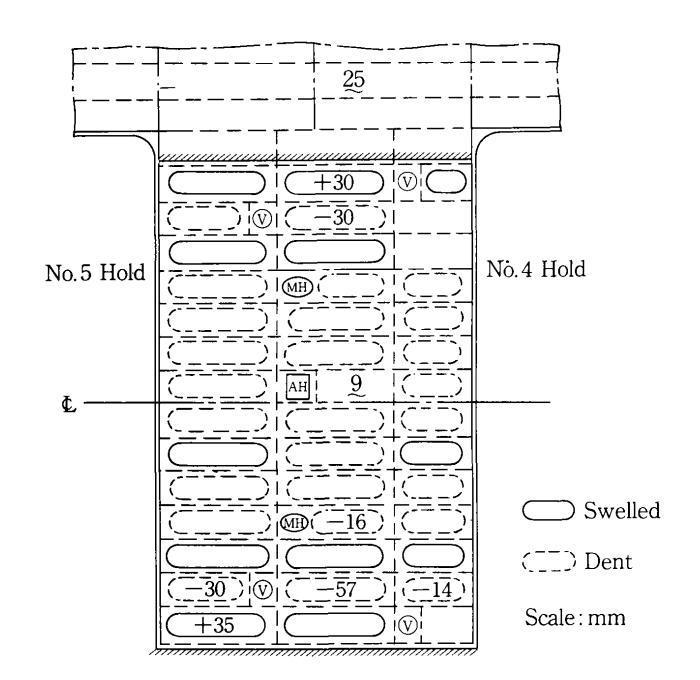
Fig. 25 Buckling damage of upper cross deck (bulk carrier)

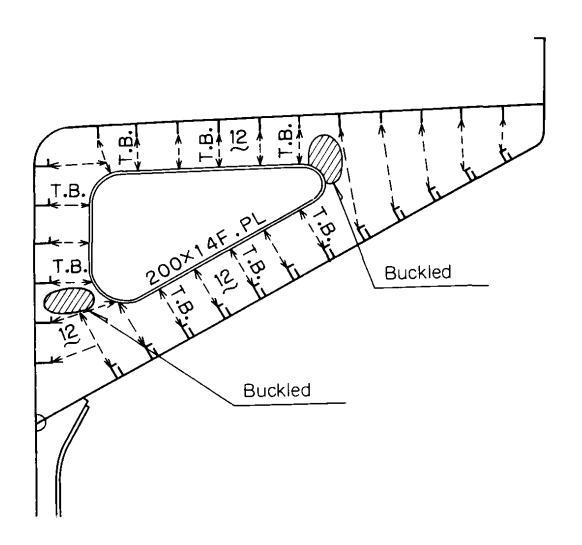
(4) Buckling of balance brackets in topside tanks Balance brackets are provided at the upper ends of hold frames in topside tanks, and they sometimes fail due to buckling. Therefore, attention should be given to the required stiffening arrangements. These members constrain rotative displacements at the upper ends of hold frames, and the upper ends on the side of face plates are subjected to compression in ordinary cargo holds, and are subject to tension in cargo/ballast holds.

Fig. 26 Buckling damage of trans. girder in top side tank

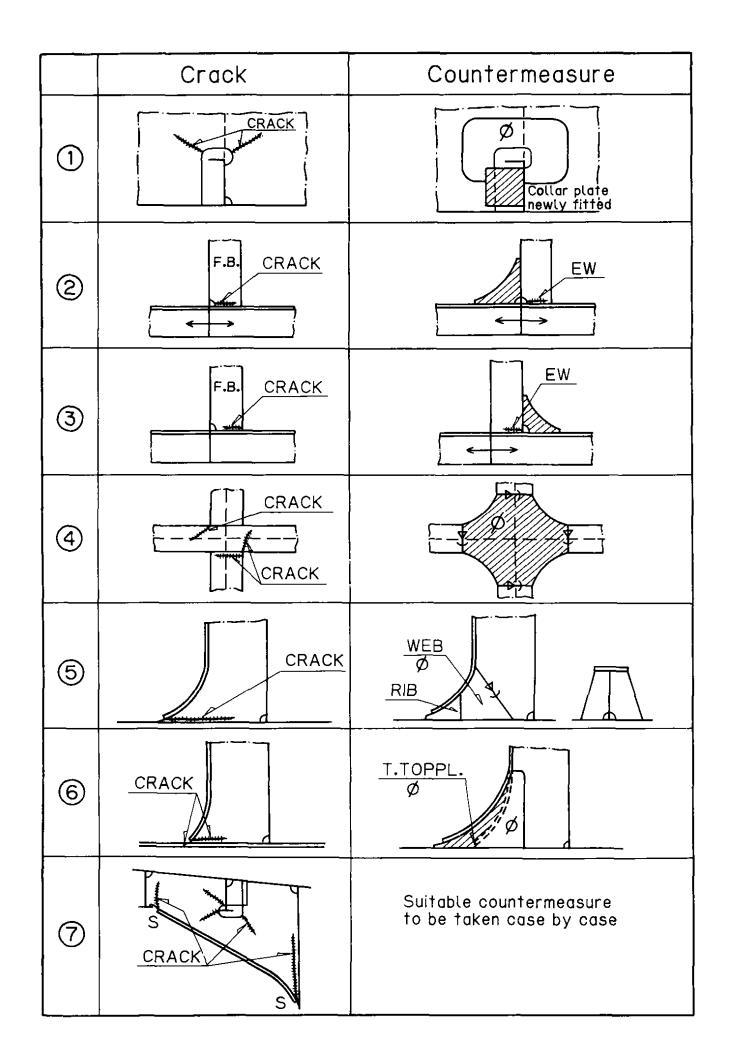
(1) shows a cracking failure at slots in the web plates of main girders, in which high bending and shearing stress levels, stress concentrations due to the slot geometry

Fig. 28 Typical crack damage of girders and the countermeasure

and corner radius at corners are relevant. Recurrence of cracking failures can be prevented by cropping and renewing web plates and fitting collar plates. In deep bottom girders in oil tankers, the off-theplane deformation of web plates can be relevant. In this case, recurrence is prevented by installing additional tripping brackets.

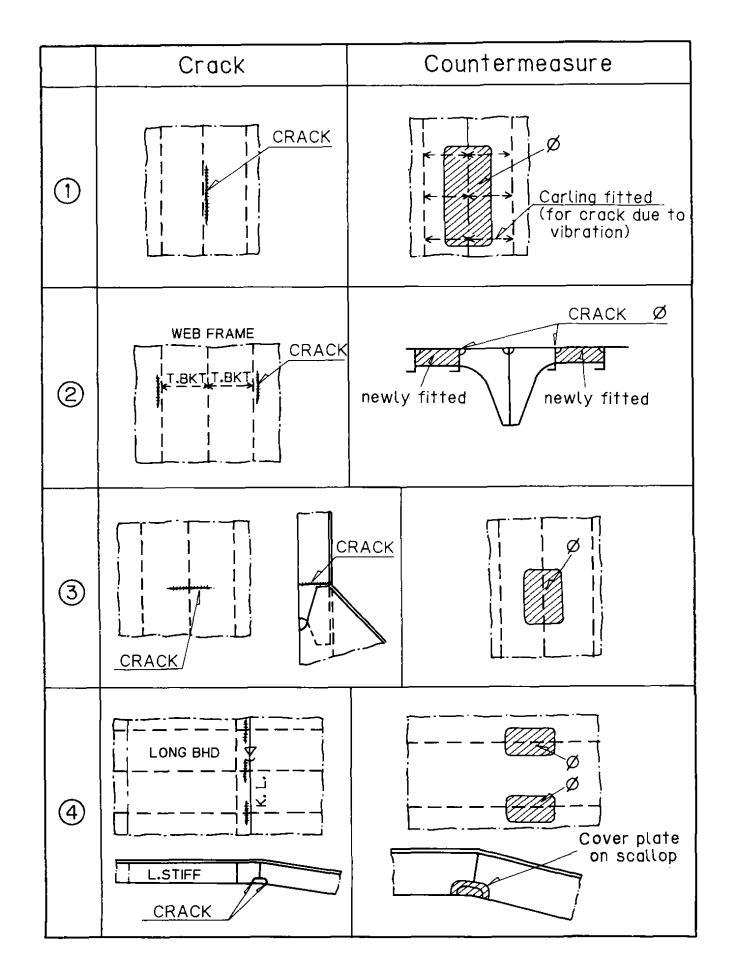
(1) shows the cracking failures running along stiffeners or frames, and if those caused by vibrations are excluded, many are caused by worn plate members. In dealing with cracking failures due to wastage, extensive plate renewal is necessary, and when caused by vibrations, it is

Fig. 29 Typical crack damage of plates and the countermeasure

necessary to reinforce the panel by fitting carlings.

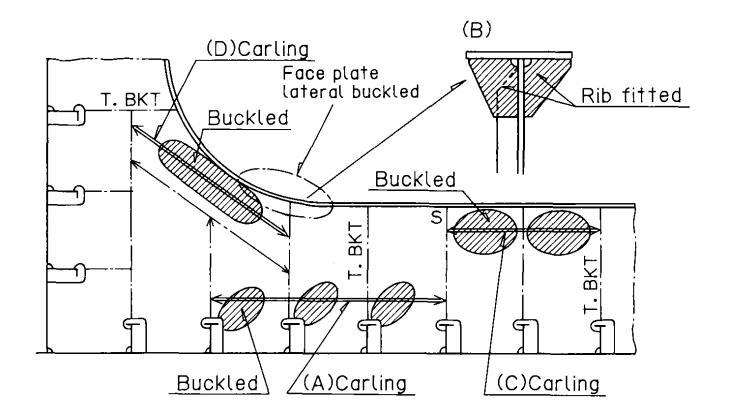
Fig. 30 An example of reinforcement for buckled girder

It is effective if carlings are fitted in the direction normal to the working direction of buckling, but they may be fitted as shown in (A) if structural features so require. It generally holds that when buckling deflection is within 20 mm or thereabouts, reconditioning through fairing coupled with fitting of carlings is feasible, but in some cases, cropping and renewal of web plates may be called for. Tripping of face plates is seen, although it is rare. In such a case, fit ribs as shown in (B) of the figure.
