DRY DEBRIS FLOW OF PYROCLASTIC FALL DEPOSITS TRIGGERED BY THE 1978 IZU-OSHIMA-KINKAI EARTHQUAKE: THE "COLLAPSING" LANDSLIDE AT NANAMAWARI, MITAKA-IRIYA, SOUTHERN IZU PENINSULA

Masahiro CHIGIRA

Geology Department, Civil Engineering Laboratory, Central Research Institute of
Electric Power Industry, Abiko City, Chiba

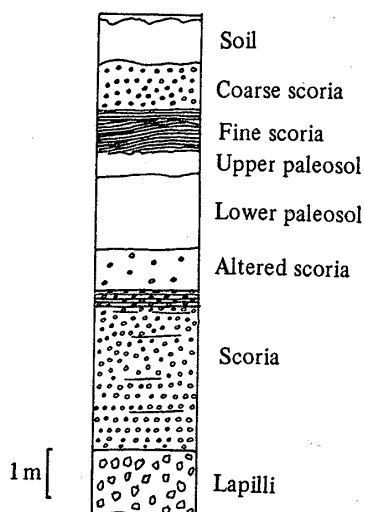
Fig. 4 Schematic columnar section of the pyroclastic fall deposits at Nanamawari.

The succession of the beds in ascending order is lapilli (more than 1 m thick), scoria (3 m 40 cm), altered scoria (80 cm), paleosol (1 m 20 cm to 2 m), fine scoria (60 cm to 1 m), coarse scoria (1 m), and soil (60 cm to 1 m) (Fig. 4).

The sliding surface formed in the paleosol [4] and this caused the 300 to 350 cm thick layers above it to slide. Part of the paleosol and the layers above it show as an outcrop at the cliff that surrounds the source area. Part of the paleosol and its underlying strata show as an outcrop at the stream wall.

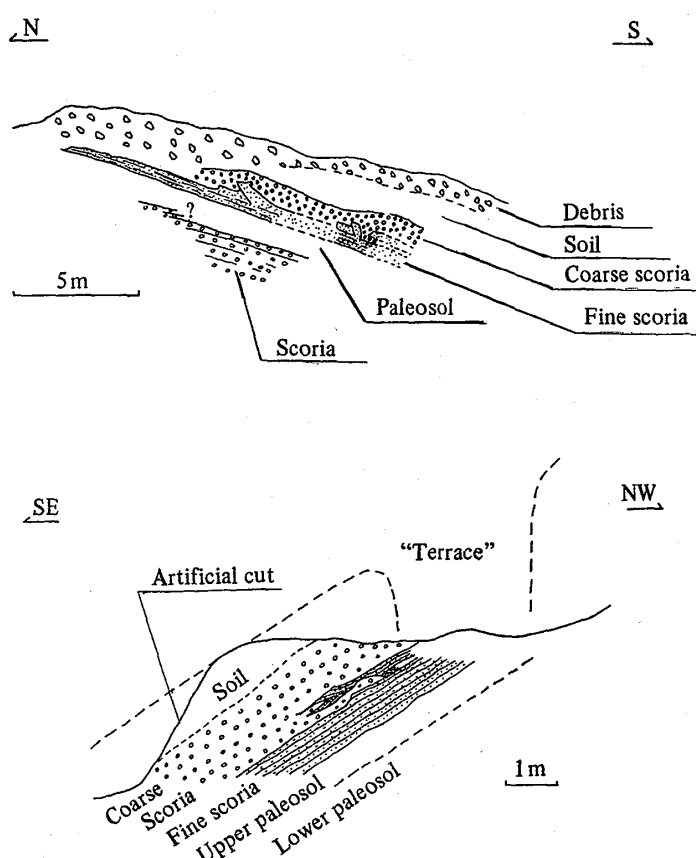
Fig. 5 Sketches showing the trace of an old landslide, (loc. 1 [upper] and loc. 2 [lower] shown in Fig. 3.). The upper part of the fine scoria bed protrudes into the lower part of the coarse scoria bed, but as a whole stratification is well preserved.

At the trench, the upper part of the fine scoria bed thrusts a thin layer, about 10 cm thick, into the lower part of the coarse scoria bed above it (Fig. 5). In contrast, the base of the fine scoria bed has not been disturbed. In general, stratification is well preserved.

Distortion of stratification is restricted to the upper part of the fine scoria and the lower part of the coarse scoria beds. It does not extend to the lower part of the fine scoria bed. This shows that the distortion was caused by the sliding of the upper part of the fine scoria, the coarse scoria and the soil, the sliding surface being within the fine scoria bed, not within the paleosol. The distorted part is tight with no open cracks; thus, the sliding shown by this distortion was not

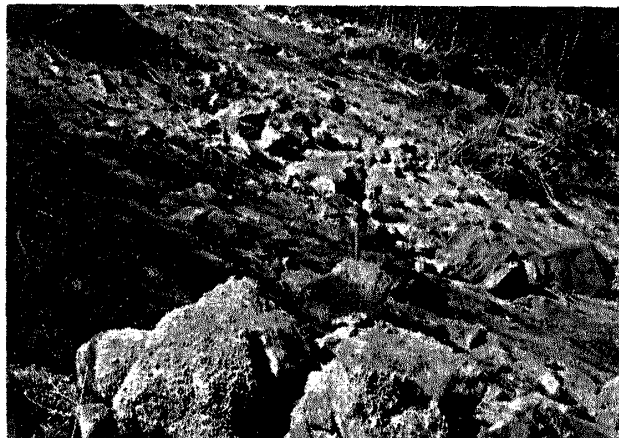
Photo 2 Soil layer blocks and debris remaining in the upper part of source area A in Fig. 4.

In the upper part and on the lateral sides of source area A, much debris, about 1 m or more thick, remains as well as many soil layer blocks that are limited by the root systems of one or more of the trees in them (Photo 2). Most trees in the blocks were standing and alive in June 1978. The debris is especially thick along the lower northeastern side.

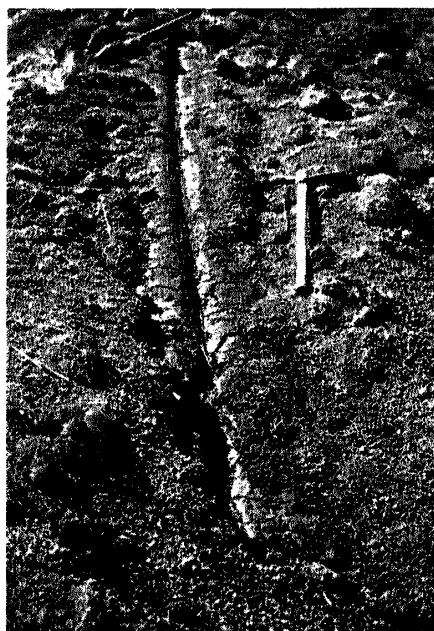
Photo 3 Sliding surface with groove-like striations in the paleosol.

1. A sliding surface, slickensided on the paleosol with many groove-like striations, was found in patches of outcrops in the source area because a considerable amount of the fine surface debris had been washed away by rain after the landslide (Fig. 3 and Photo 3).
2. Undisturbed paleosol was found beneath the debris at six points along the foot of the cliff around source areas A and B (Fig. 3). At one point, on the uppermost part of source area A, undisturbed paleosol is present beneath the debris at a place where the moving debris probably had not considerably hollowed the paleosol.
3. The landslide debris is composed only of the paleosol and materials from the beds above it.
4. Some blocks of debris contain paleosol material as well as scorias.

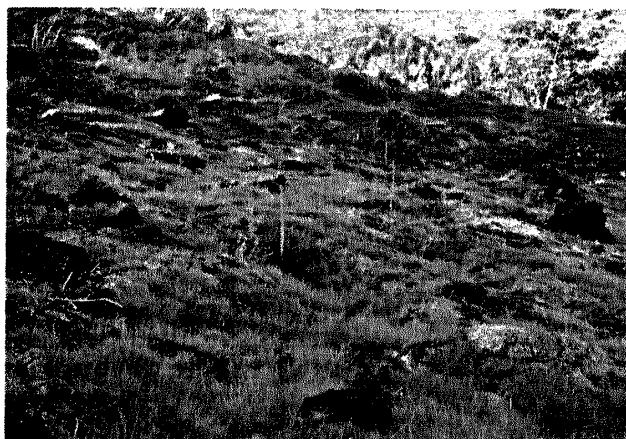
Photo 5 Small mounds of paleosol clods at the proximal part of depositional area A', June 1978. Grass grew after the slide.

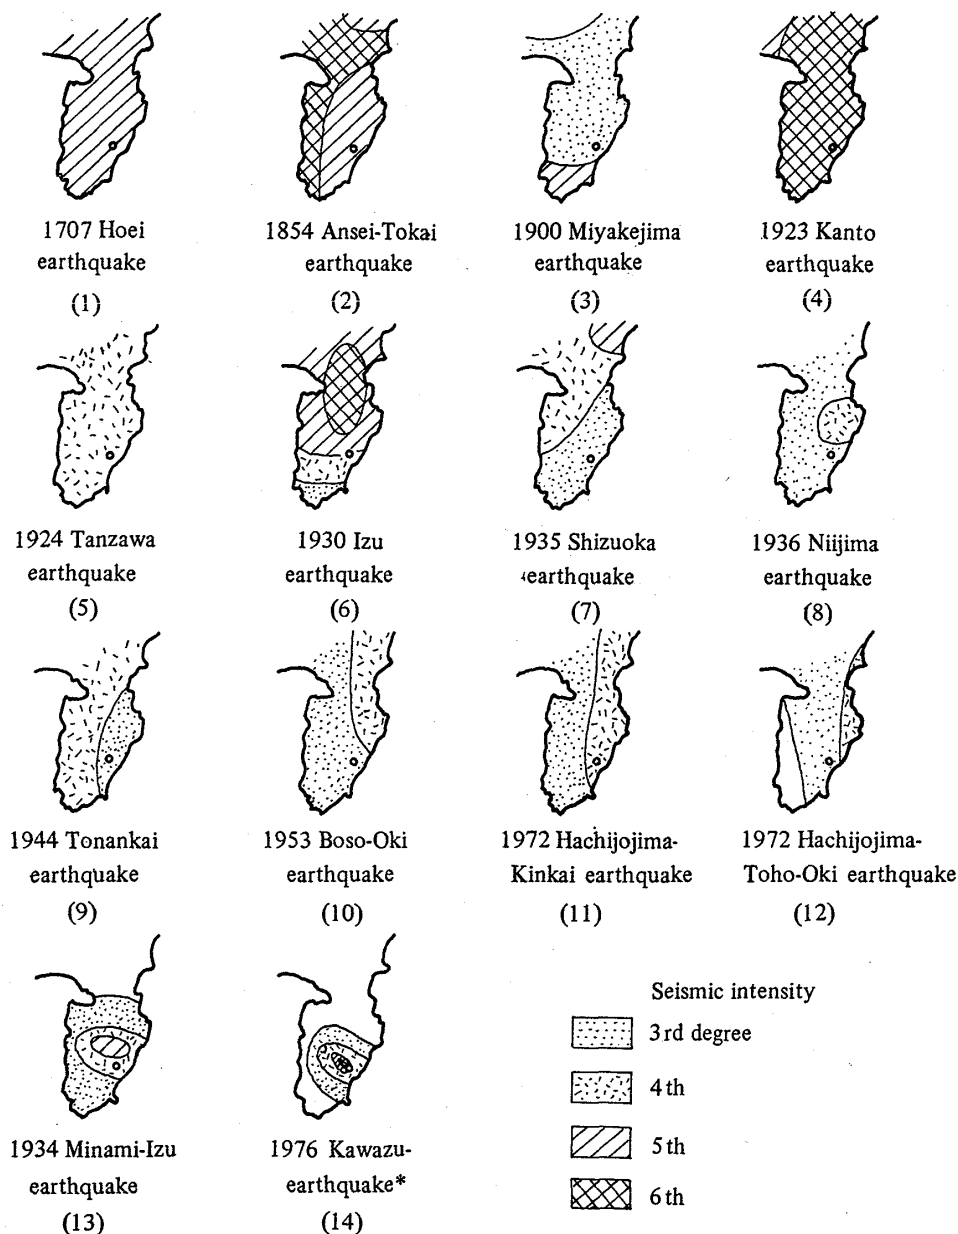
Fig. A-4 Isoseismals of past large earthquakes in the Izu Peninsula. Mitaka-iriya is shown by the open circle. The figure marked * is from Murai [26]; all the others are reproduced from Usami [18].

In contrast, the largest horizontal acceleration during the 1978 earthquake at Mitaka-iriya was estimated as 400–450 gals from the survey of toppled tombstones [15]. This accounts for the 1978 sliding at Nanamawari in Mitaka-iriya being caused by the earthquake, even though the above discussion assumes an “infinite” slope and a static force provided by the earthquake.
