LIQUEFACTION DAMAGE TO THE GROUND DURING THE 1983 NIHONKAI-CHUBU (JAPAN SEA) EARTHQUAKE IN AKITA PREFECTURE, TOHOKU, JAPAN

ABSTRACT

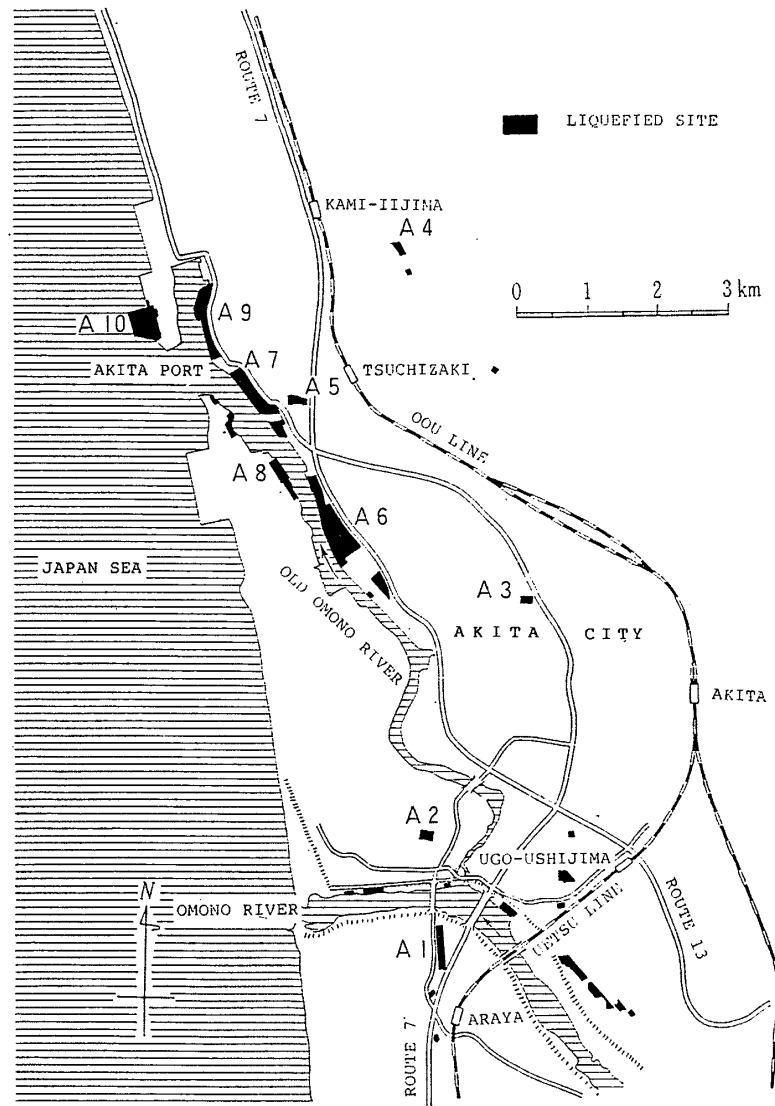
Fig. 3 Liquefaction site distribution map in Akita City after the Nihonkai-Chubu earthquake.

The distribution of liquefaction sites in Akita City is shown in Fig. 3. At Araya-Motomachi (Site A1) in the south of the city, liquefaction occurred in a long, narrow area running north-south. Many sand volcanos were found in house gardens and open spaces, and there was many tilts of houses, settlements of roads, and breakages of life lines. This site is on an old river bed shown on an old map drawn about 70 years ago (Fig. 5). At Araya-Matsumi-cho (Site A2) and Iijima (Site A4), the damage was less than at Araya-Motomachi.

At Akita Port, liquefaction was very widespread and much of the port's equipment was severely damaged. At Honkoh (main harbor), liquefaction occurred throughout the Akita Oil Storage Tank yard (Site A6), as shown by the uneven settlement of the oil tanks, the floatation of buried tanks and the collapse of oil fences. At D Quay and the Nakajima 1-3 Quays at the South Quay in Honkoh (Site A7), an quay wall was moved seaward. In addition to the apron stage subsidence and collapse, the foundation of a warehouse was broken, a conveyer tank was destroyed and the public lavatory was settled unevenly.

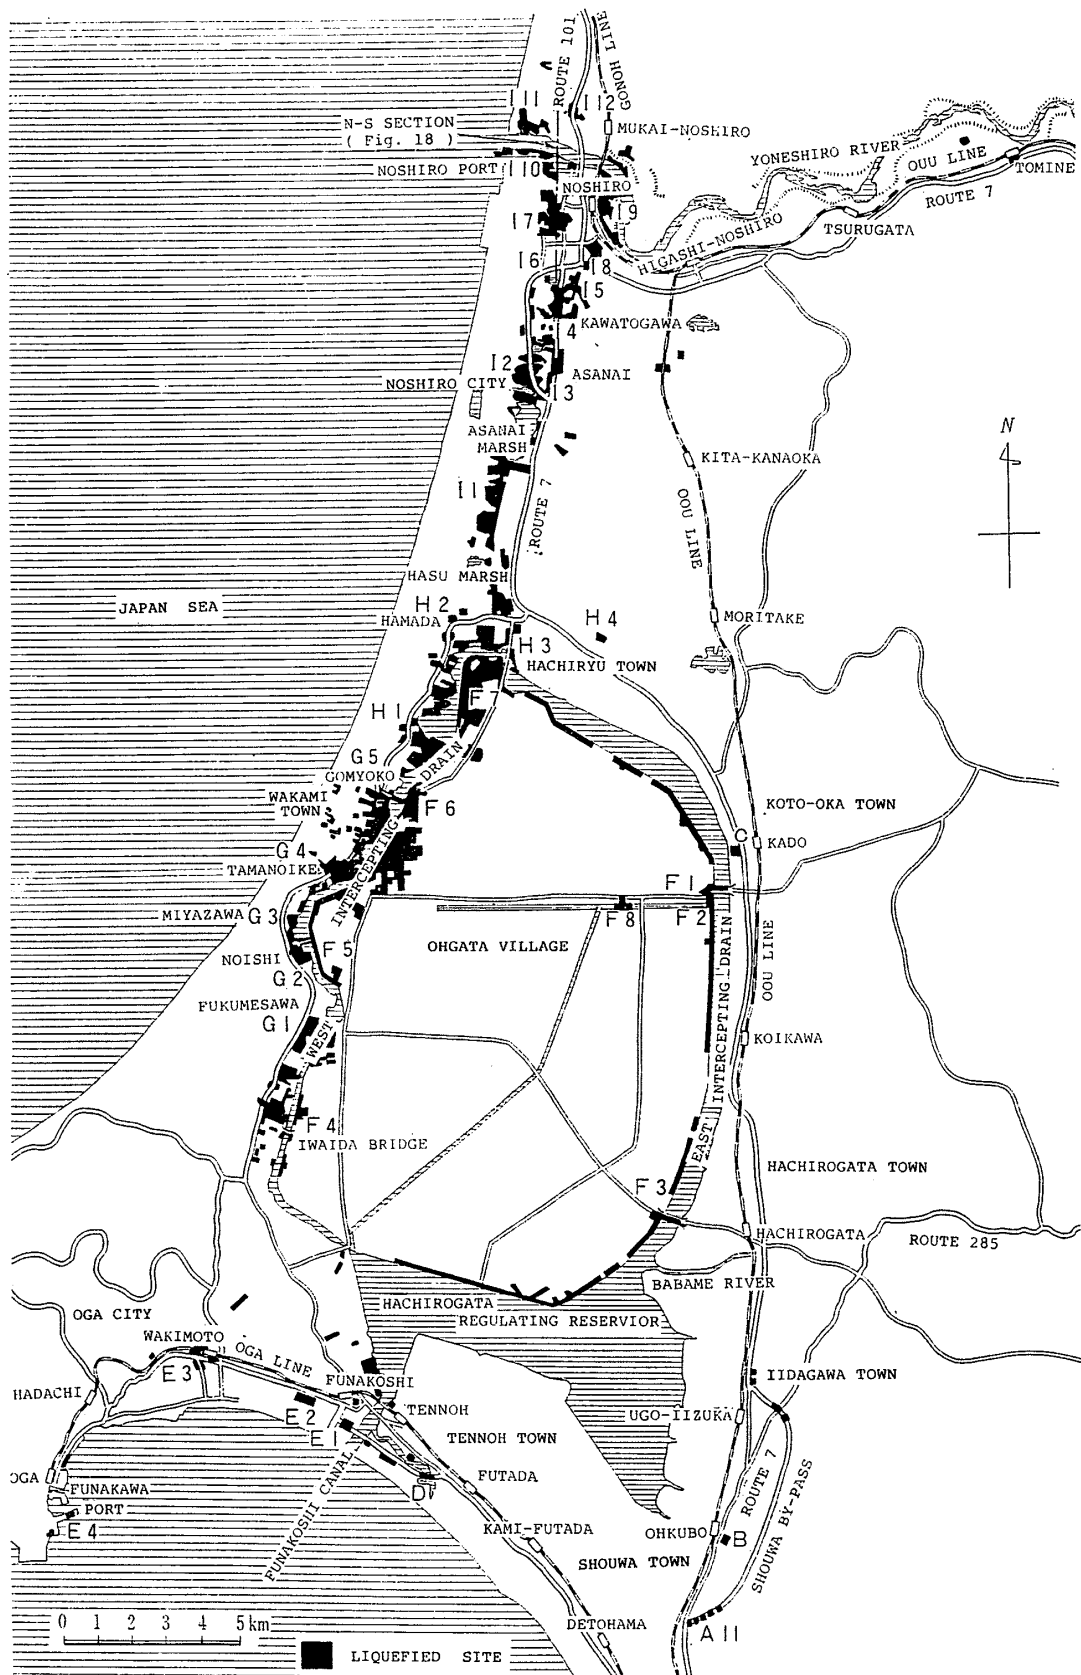
Fig. 4 Liquefaction site distribution in northwest Akita Prefecture after the Nihonkai-Chubu earthquake.

The distribution of liquefaction sites in Oga City is shown in Fig. 4. At the Oga Prefectural Industrial High School, constructed on reclaimed ground on a marsh at Maeno (Site E2), sand volcanos were present on the playing grounds, around the school building and inside open cracks

Distribution of liquefaction sites in Ohgata Village is shown in Fig. 4. The central reclamation zone at Hachirogata Lagoon was the most severely damaged area. All the embankments around this zone (Site F) showed subsidence and bulging except for small sections in the south-east and southwest. The total length of the damaged embankment was about 70 km. Liquefied

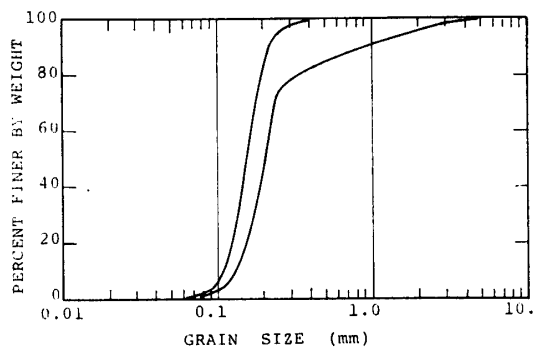
Fig. 6 Grain size distribution curves of sands liquefied by the Nihonkai-Chubu earthquake at Gaikoh (Site A10).

are reclaimed and filled ground on the Old Omono River bed. The liquefaction site at Gaikoh is reclaimed land on a shallow sea bed, and the liquefaction site at Ohama is at the new quay which had been constructed just before this earthquake. All the damage caused by liquefaction in Akita Port took place on artificial or reclaimed ground. At Gaikoh, the liquefied materials were well sorted, fine-grained reclaimed sands (Fig. 6).

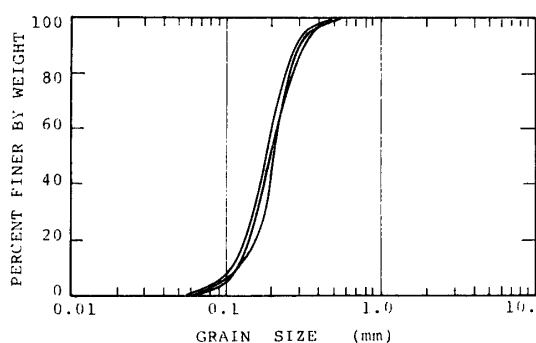
Fig. 7 Grain size distribution curves of sands liquefied by the Nihonkai-Chubu earthquake at Oga Prefectural Industrial High School (Site E2).

on the ground surface (Photo. 7). The floor of an engineering workroom, a one-story building, showed a maximum subsidence of 40 cm. A house next to tennis courts was destroyed because the lot slipped and collapsed (See Photo. 8). An aerial photograph (Photo. 9) shows sand volcanos and cracks on the surface of the ground all around the high school and on house lots near the school, but there was neither liquefaction nor damage in weak paddies took place on Alluvial lowland. The liquefied materials at this high school were well sorted and fine-grained reclaimed sands with the mean particle size, D_{50} , of about 0.2 mm and the uniformity coefficient, U_c , of about 1.8 (Fig. 7).

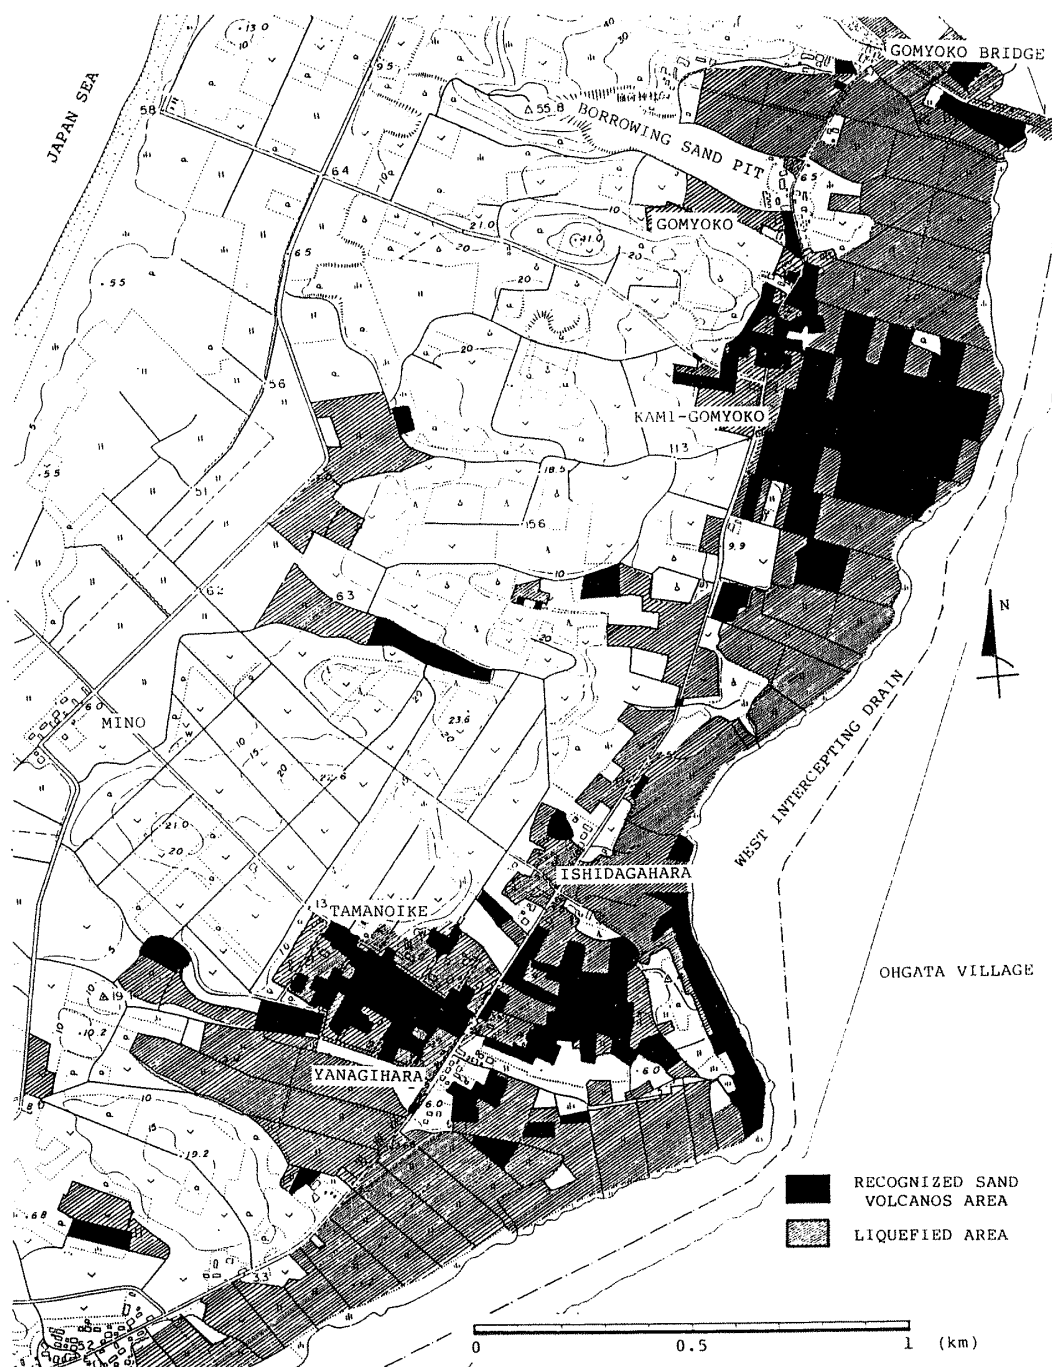
Fig. 10 Liquefaction site distribution map after the Nihonkai-Chubu earthquake in northern Wakami Town.

cracks in the surface of road can be seen. There is also complete and partial collapse of houses, tilting and destruction of concrete block fences and tilting of electric light poles. There was heavy damage to paddies and to farms. Damage caused by liquefaction was especially marked at Tamanoike (Site G4) and Gomyoko (Site G5) in Wakami Town.

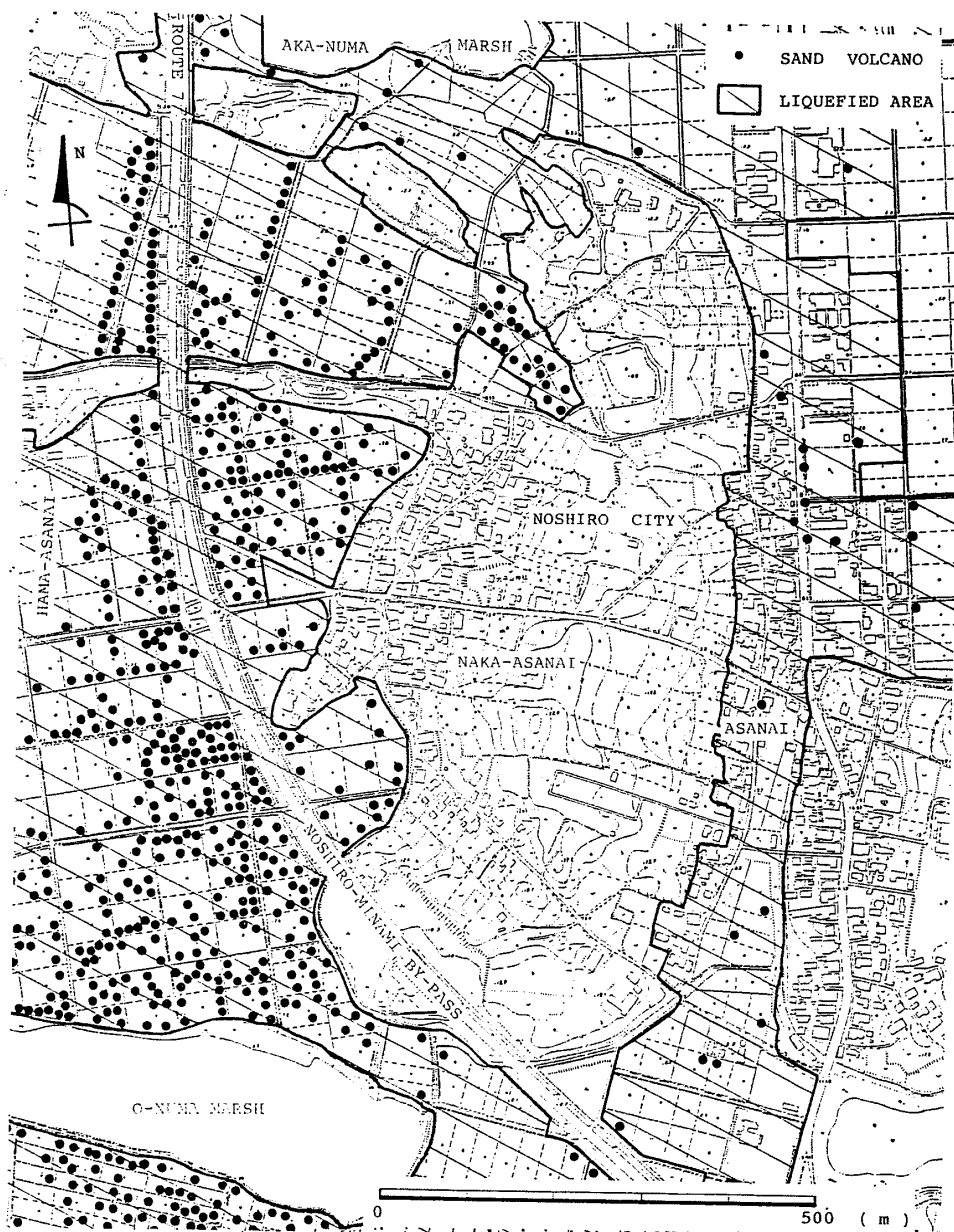
Fig. 11 Liquefaction site distribution map after the Nihonkai-Chubu earthquake at Asanai, Noshiro City.

Koado (Site I11). At Kawatogawa, many gateposts and concrete block fences were tilted or destroyed. A buried oil tank at a gas station was raised about 70 cm, and the footing of a house and both edges of the road were badly broken (Photos. 19–20). Liquefied sand sample at the side of a road at Asanai was fine-grained with a mean particle size, D_{50} , of 0.33 mm and a uniformity coefficient, U_c , of 1.9 (Fig. 12). The detailed distribution of the liquefaction sites at Kawatogawa is shown in Fig. 13.

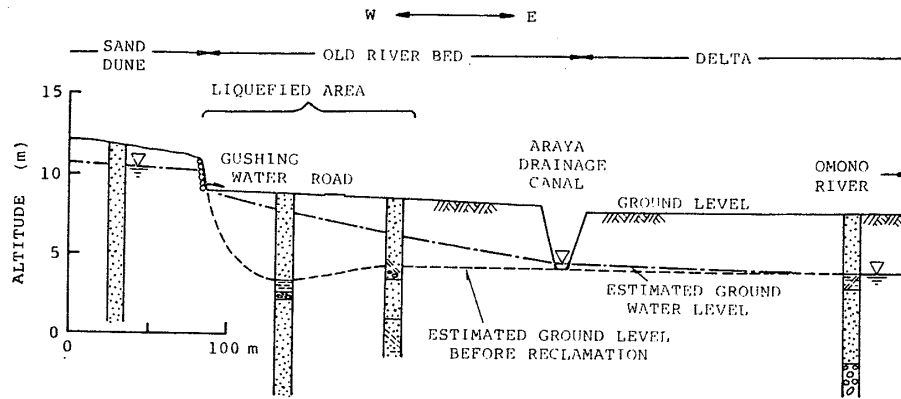
Fig. 15 Estimated east-west ground section of Araya-Motomachi, Akita City (Ref. [6]).

[6] for the area damaged by liquefaction is shown in Fig. 15. The ground water level was shallower [6] at the time when the area was damaged by the liquefaction, also, the ground water level was shallower than at the time this area was reclaimed. The estimated ground water level, divided between the area damaged by liquefaction and the area of no liquefaction, is about G.L. -2 m. The reclaimed fill is a weak sand layer whose N value is 5 based on the Standard Penetration Test.

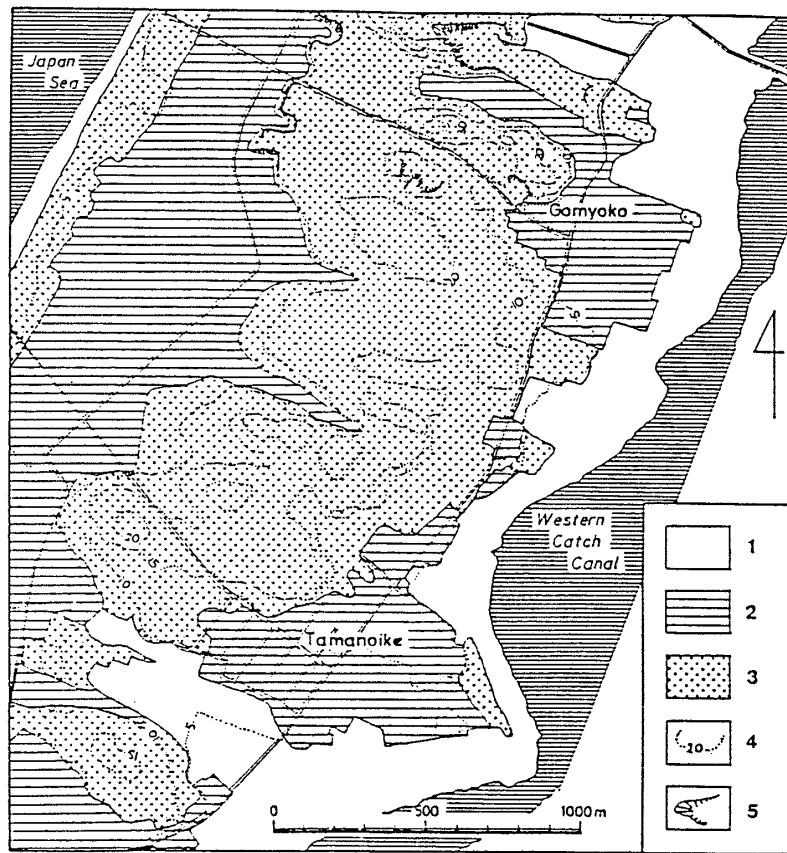
Fig. 16 Geomorphologic map of northern Wakami Town (Ref. [7]).

Kuwahara et al. [9] has reported that the most common ground failure areas in Aomori Prefecture caused by the liquefaction produced during this earthquake were blow-out depressions of parabolic sand dunes at the Tomiyachi district, Shariki, Aomori Prefecture. Probably, the terraces in the northern part of Wakami Town reported by Shiraishi [7] are blow-out depressions

of parabolic sand dunes (Fig. 16).

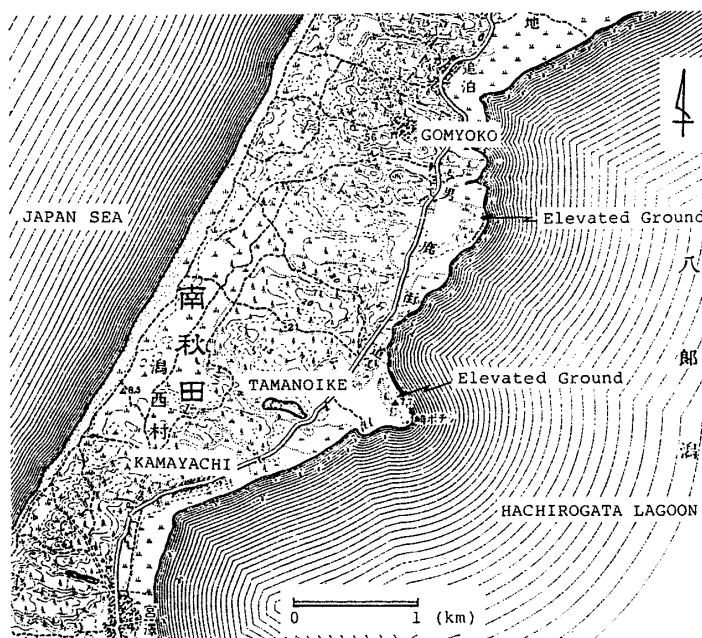
Fig. 17 Old topographic map of 1914 of northern Wakami Town.

Numerous sand volcanos were presented on the terrace in the Gomyoko and Tamanoike districts. An old topographical map (1914) of the northern part of Wakami Town is shown in Fig. 17. Arched, elevated ground looking like small hills are located along the lacustrine line of the Hachirogata Lagoon. Mii [8] described these elevated mounds as Recent sand dunes. In this area, the present topographical features are the result of recent rapid natural conditions due to human usage of the land.

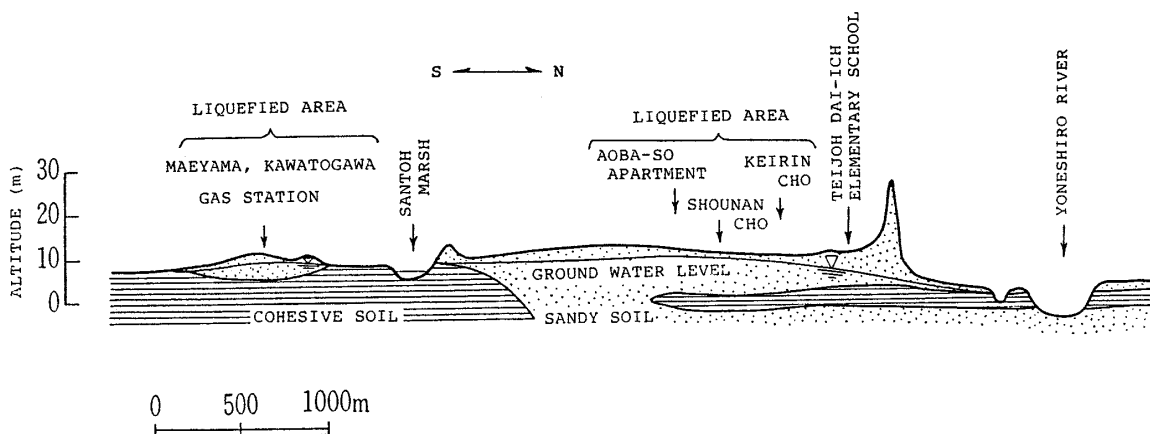
Fig. 18 Estimated north-south ground section at Noshiro City (Ref. [3]).

The estimated north-south section of ground changed in Noshiro City is shown in Fig. 18. A sand dune was formed at south of the Yoneshiro River, flat lowland continuing from Keirincho to Kawatogawa behind it. Damaged parts of Noshiro City centered along the borders of sand dunes and in the alluvial lowlands. No liquefaction was presented along the northern part of the sand dune at the Teijoh Dai-ichi Elementary School (Fig. 18). Old topographical map of 1914 (Fig. 19) shows there was a marsh at Shonan-cho, an area reclaimed in 1967 by the Noshiro City Office.
