地形 第33巻第4号 365-384頁 (2012)

Two Distinguished Effects of the 2011 Great Tsunami to the Coasts along Sendai Bay: Damage to Arahama and Trench Formation behind the Dike on Yamamoto Coast

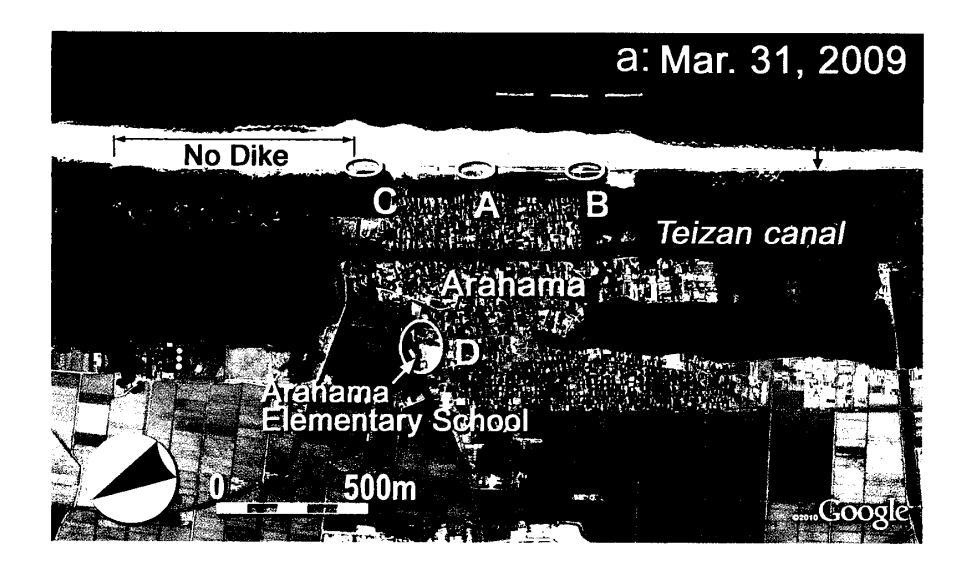
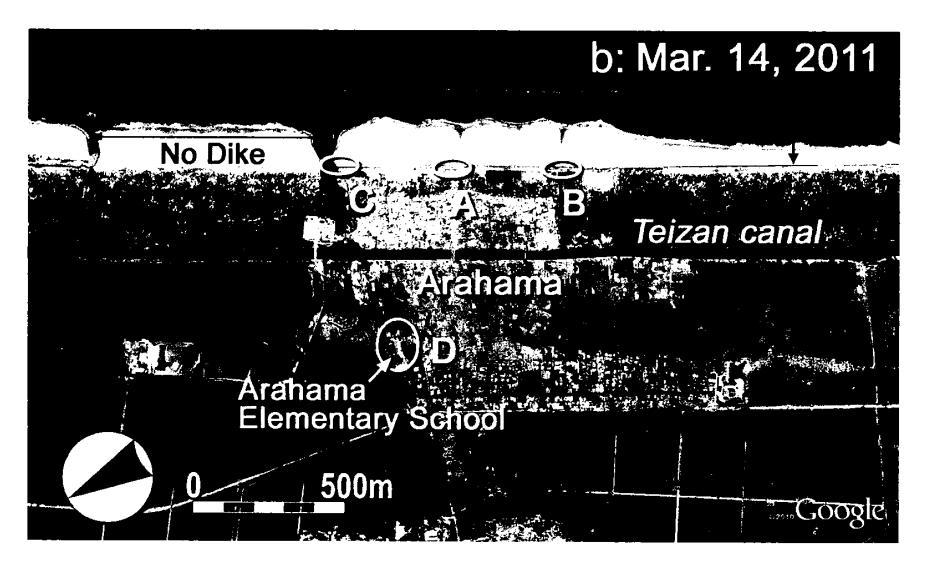
Fig. 3. Satellite image of Arahama obtained on March 31, 2009, and on March 14, 2011.

Fig. 2. Figures 3 (a) and 3 (b) show the same areas before and immediately after the tsunami, respectively. Points A-D in Fig. 3 show the locations of site observation. Arahama had been separated into two parts by the Teizan canal, and the residential area extended seaward of this canal over 200 m. The coastal forest extended over 70 m seaward of the residential area, which protruded into the coastal forest zone, and the sandy beach further extended over 140 m. In addition, six detached breakwaters had been constructed offshore to protect the residential area against waves. Although it is difficult to recognize its location in Fig. 3, a straight coastal dike with a crown height of +6.2 m above MSL extended between the coastal forest composed of mainly pine trees and the sandy beach. The tsunami inundation height in this area reported by the research group of JSCE was approximately 9.5 m. This part of the Teizan canal, which separates the residential area into two parts, was excavated during the early Meiji era in

The residential area in Arahama was completely destroyed, in particular, the houses were destroyed to their foundations in the seaward area of the canal, and sand was deposited over the debris of houses, which was transported by landward tsunami currents. Although the coastlines north and south of the detached breakwaters continuously extended before the tsunami, as shown in Fig. 3 (a), the sandy beach in the lee of the north detached breakwater disappeared, and a channel of 80 m width was formed by the tsunami (Fig. 3 (b)). This channel expanded a long distance landward as a wedge along the north end of the residential area in Arahama. The location of the newly formed channel is superimposed to the junction between two small rivers, at which two rivers obliquely joined each other before the tsunami (Fig. 3 (a)), suggesting that its elevation was relatively low. The return flow of tsunami inundated deep inland was partly blocked by the coastal dike, causing longshore return flow along the coastal dike. The concentration of such flow is assumed to one of the reasons for the formation of such a channel. Once a channel was formed, the return flow of tsunami was expected to concentrate further in this channel. A similar channel perpendicular to the shoreline was formed 800 m north of this channel, as shown by a thick black arrow in Fig. 3 (b).

observed, as shown in Fig. 11. Before the tsunami, this area was covered with a coastal forest (Fig. 3 (a)); however, after the tsunami, it was severely eroded, leaving a wide channel (Fig. 3 (b)). Considering that there was a sandy beach before the tsunami, as shown in Fig. 3 (a), this channel was considered to be formed by the concentrating return flow of tsunami. Further north of this channel perpendicular to the shoreline, there were no coastal protection facilities, with only a wooden fence preventing wind-blown sand from entering the area (Fig. 12), enabling the tsunami to inundate the hinterland easily.

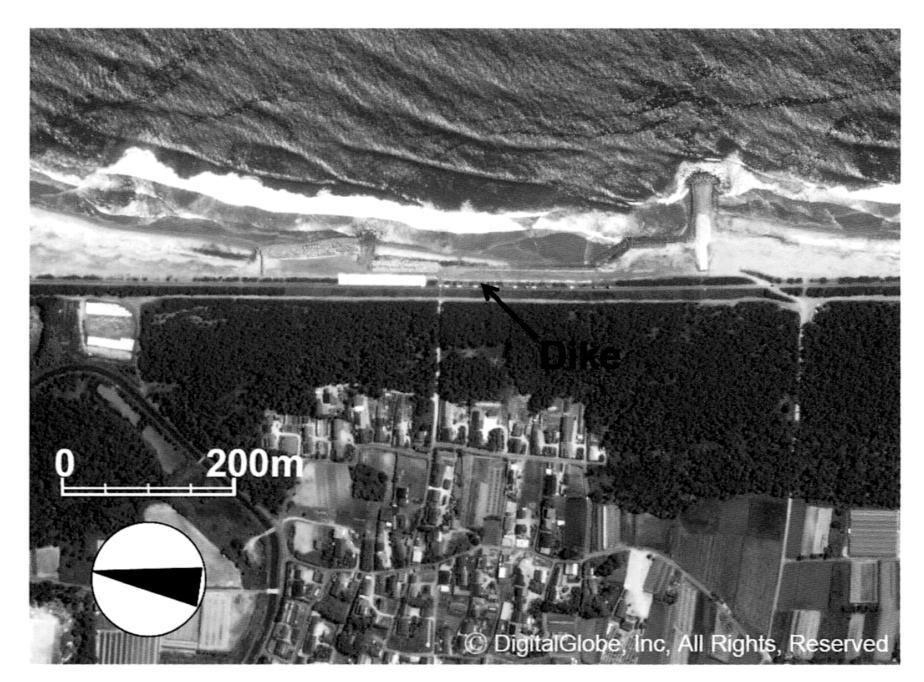
Fig. 16. Satellite image of Yamamoto coast (August 2010).

The Yamamoto coast had been protected by a straight coastal dike with a crown height of 6.5 m above MSL along with a coastal forest of 200 m width, as shown in Fig. 16, before the tsunami. During the tsunami, the coastal dike was destroyed, all the trees were uprooted and transported landward, and a continuous trench was formed along the coastal dike, as shown in Fig. 17. Moreover, many indentations of irregular shapes were formed in the inland part of this continuous trench by the return flow of the tsunami. The tsunami run-up height was 19.2 m above MSL at 6.5 km south of this area (Public Works Research Center, 2011), which was three times larger than the crown height of the coastal dike, 6.5 m above MSL.

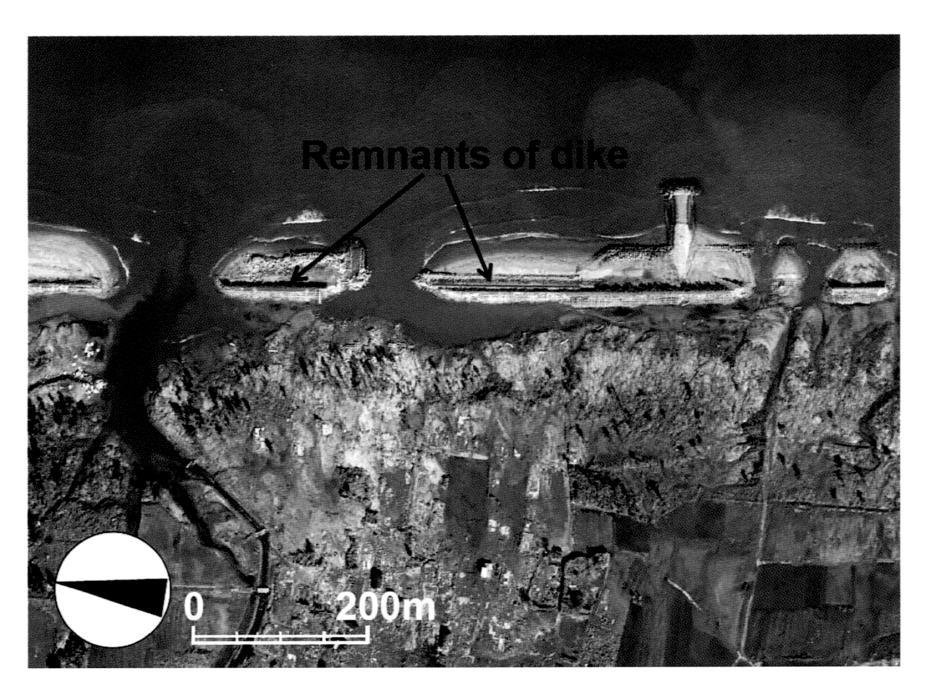
Fig. 17. Satellite image of Yamamoto coast (March 12, 2011).

On the Yamamoto coast, during the great tsunami with a height of 19.2 m, a large trench of approximately 50 m width was formed immediately inland of the coastal dike, and the back slope of the dike was destroyed. Figures 16 - 18 show satellite image of the Yamamoto coast obtained in August 2010, on March 12, 2011, immediately after the tsunami, and in April, 2011, respectively. The numbers in Fig. 18 correspond to the locations where site photographs (Figs. 19 – 27 and 29) were obtained.

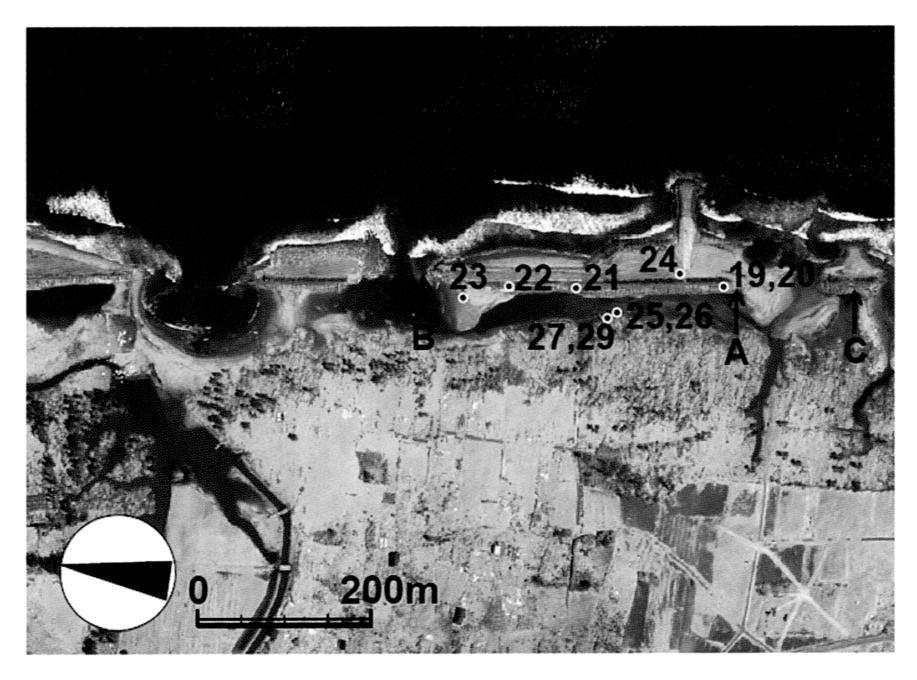
Fig. 18. Satellite image of Yamamoto coast and locations where photographs were obtained (April, 2011).

Although the trench was formed behind the undestroyed coastal dike, the irregular coastline with many indentations formed by the return flow was reduced to a smooth shoreline of pocket beaches by April 6, 2011 owing to the action of waves diffracted from the opening, as shown in Fig. 18.

Field observation was carried out along the coastal dike between points A and B indicated in Fig. 18. Although the coastal dike extended between points A and C, 100 m south of point A, before the tsunami, the coastal dike was severely destroyed, as shown in Fig. 18. Sand bars extended landward from the south and north ends (A and B) of the coastal dike, respectively, and a trench continuously extended behind the

Figure 19 shows a part of the destroyed coastal dike, facing south from point A shown in Fig. 18. At a location 100 m south of point A, the remains of the coastal dike were observed and the sandy beach extended between points A and C. Sand deposition was not observed near point C in April, 2011, as shown in Fig. 18, although a cuspate foreland was formed near point A. This implies that a large amount of sand was transported and deposited by wave action during the period between April, 2011 and August 12, 2011.

Figure 23 shows a photograph of the cuspate foreland behind the coastal dike, which was formed near point B as shown in Fig. 18. Because the partly destroyed coastal dike functioned as an impermeable detached breakwater, a large-scale cuspate foreland was formed behind the partly destroyed dike. In contrast to the severe damage to the back slope, no major changes were observed on the seaward slope, as shown in Fig. 24.
