Surface Contamination of Titanium by Abrading Treatment

This study investigated the contamination of abraded Ti surfaces. Using a polishing machine, specimens were abraded with waterproof SiC grit papers under water cooling. The abraded surfaces were examined using element analysis, X-ray diffraction, and hardness tests. Contaminant deposits with dimensions reaching about 30 μm were observed throughout the surface. In these deposits, Ti was apparently reduced by about 10% and replaced by Si and O. The chemical bond state of the Si was similar to that of SiC or a titanium silicide. The O was solute in Ti, which increased the surface hardness. The contaminant deposits were amorphous or very thin. The contamination of Ti, the extent of which was related to hardness, resulted from a reaction with abrasives.

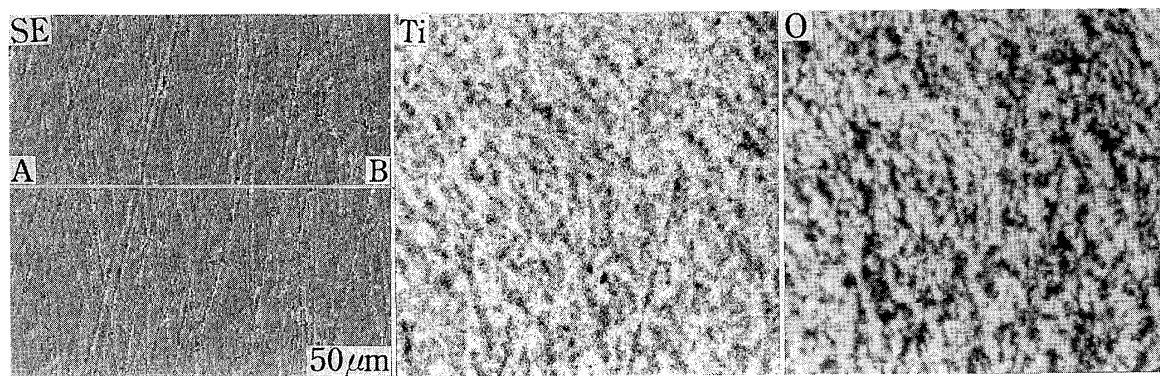
Fig. 2 Element distributions on an abraded Ti surface. Together with an 18-8 stainless steel chipping band, the specimen was resin-embedded and abraded to #1,000 grit.

The element analysis of the interior far from the reaction zone was performed at a higher magnification. Fig. 2 shows an SE image and the corresponding maps of titanium and oxygen. Areas with low titanium contents and high oxygen contents were observed overall, providing dappled and reversely dappled patterns in these element maps. For a semi-

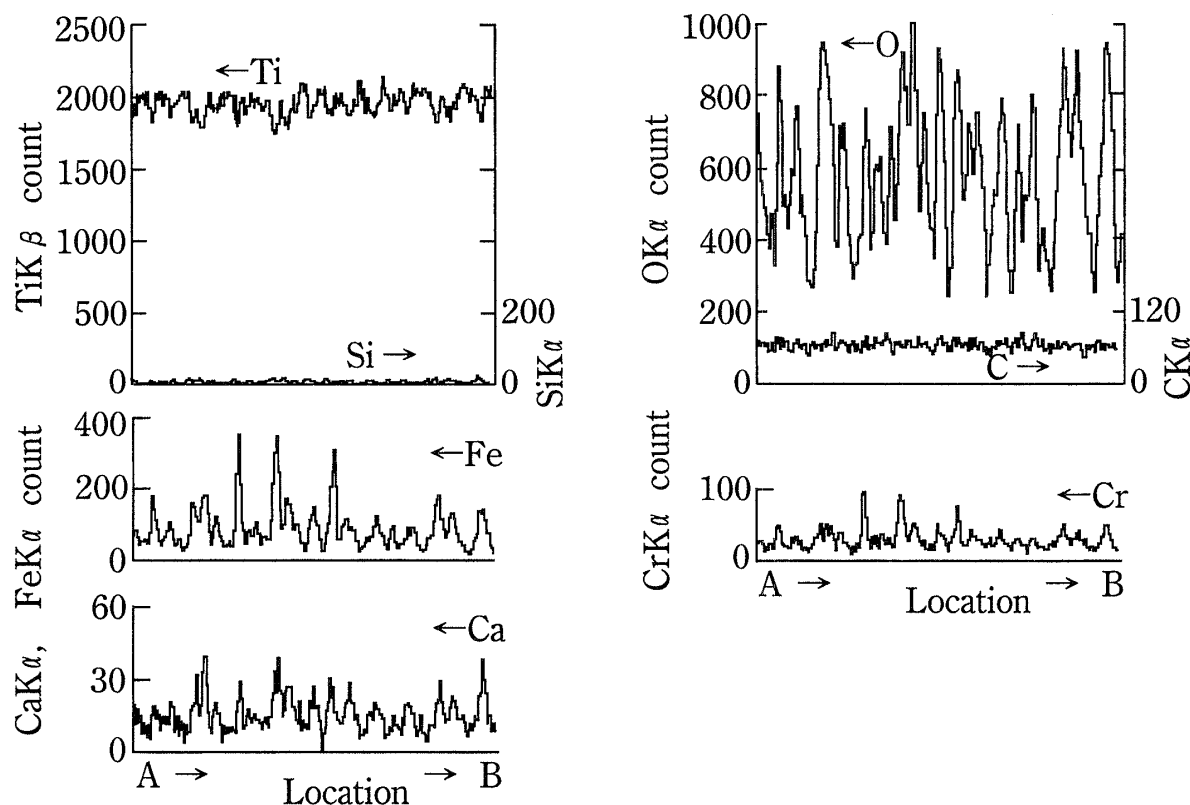
Fig. 3 Line analysis profiles of Ti, Si, O, C, Fe, Cr, and Ca along the line AB in the SE image of Fig. 2

quantitative evaluation, Fig. 3 shows line analysis profiles of titanium, silicon, oxygen, carbon, iron, chromium, and calcium along the line AB in the SE image of Fig. 2. From these profiles, it was found that the titanium content varied within about 10% of its maximum. The oxygen content, with a background of about 200 counts, varied remarkably in a range of about 200 to 1,000 counts, corresponding inversely to the distribution of titanium. In addition, iron and chromium were detected, nearly corresponding to the distribution of oxygen, though their contents were low. The iron was not an impurity included in the titanium, but a major component of the 18-8 stainless steel clipping band which was abraded together with the specimen; the distribution of iron corresponded closely to that of chromium. Nickel, which was not analyzed, could be detected together with the iron and the chromium. Calcium, which was distributed similarly to the other elements, originated from a filler component included in the embedding resin. We note here that silicon was detected not throughout but in a scattered distribution pattern in several isolated spots.

the distribution of silicon corresponded closely to that of oxygen, entirely different from the result shown in Fig. 3. However, no peculiar aspect was found in the distribution of carbon. Although the specimen was carbon-evaporated, the contaminant carbon, if it existed, ought to be distinguishable from the evaporated carbon. In data not shown here, carbon was significantly detected together with silicon and oxygen on a surface abraded with silicone rubber polishers according to established dental techniques.

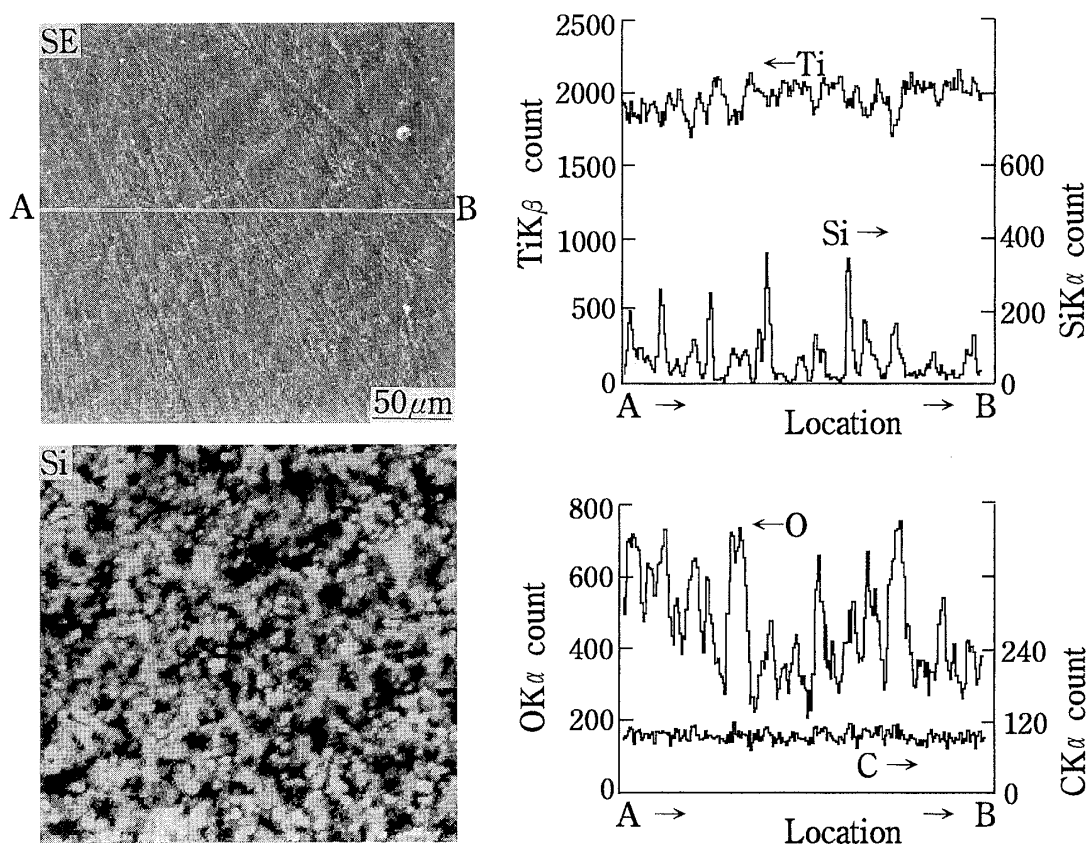
Fig. 4 Element distributions on an abraded Ti surface. The resin-attached specimen was abraded to #1,000 grit. The line analysis profiles show the distributions of Ti, Si, O, and C along the line AB.

In order to escape the influence of the stainless steel band and the filler on the contamination, resin-attached specimens were abraded and analyzed. The hard reaction zone⁴⁾ contaminated by the investment constituent elements was entirely removed by the abrading. Fig. 4 shows the results of the element analysis. The distributions of titanium and oxygen were qualitatively similar to those shown in Figs. 2 and 3. It is particularly noted here that

In the SE image of Fig. 4, occasional patterns with dimensions of roughly 10 to 30 μm were observed corresponding to the distribution of silicon or oxygen. In order to demonstrate these patterns more clearly, a specimen was set on the specimen stage at an angle of 60° to the electron beam and SE images were taken. Fig. 5 shows one of these images, in which contaminant deposits are observed overall.

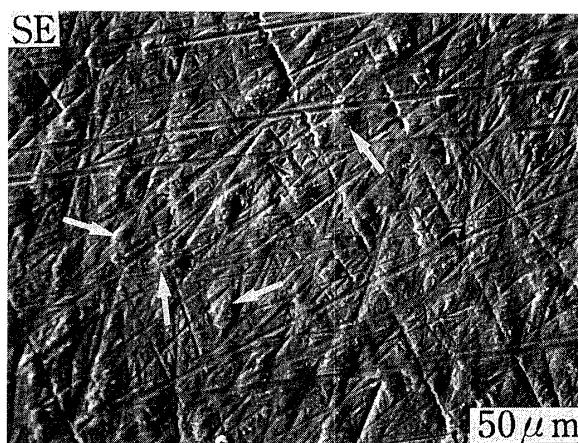
Fig. 5 An SE image showing contaminant deposits on an abraded Ti surface. Some deposits are indicated by arrows. The resin-attached specimen was abraded to #600 grit. To make the image, the specimen was set at an angle of 60° to the electron beam; the size scale is thus available only horizontally.

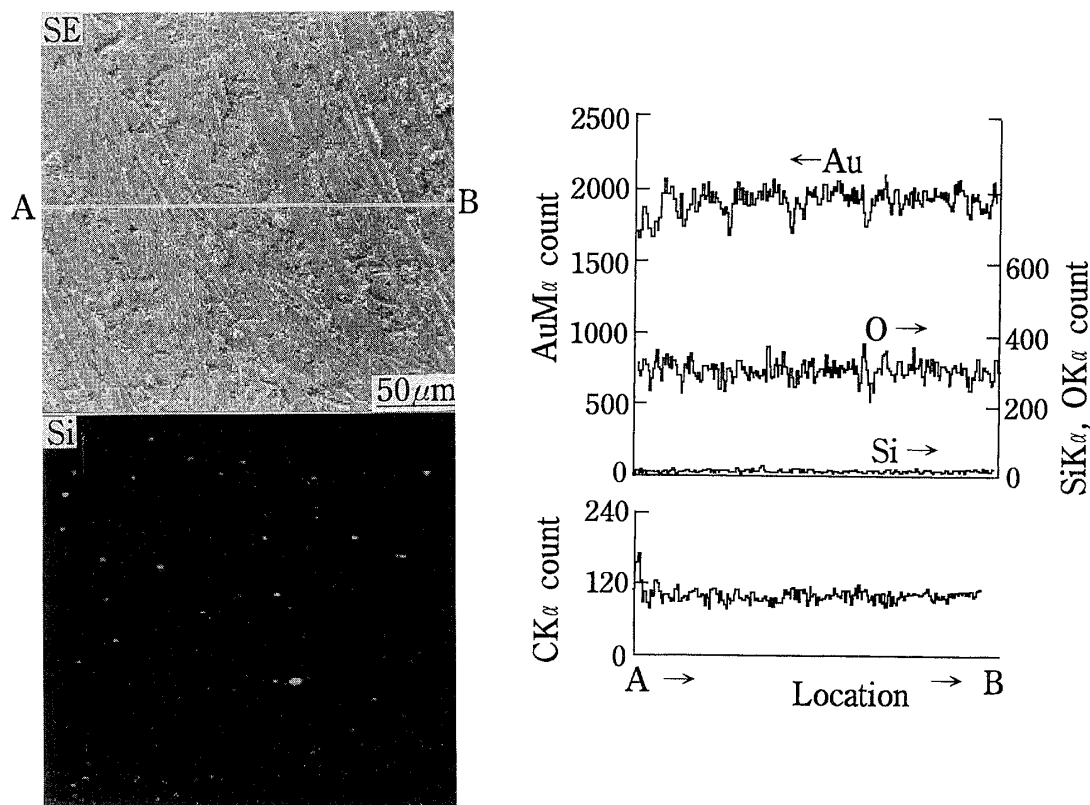
Fig. 6 Element distributions on an abraded type I gold alloy. The resin-embedded specimen was abraded to #600 grit. The line analysis profiles show the distributions of Au, O, Si, and C along the line AB.

To test this hypothesis, another examination was performed using a type I dental casting gold alloy (55 to 90 Hv, ADAS #5). Fig. 6 shows the element distributions on the surface abraded to #600 grit. As described in Fig. 3, silicon was detected not overall but occasionally, suggesting the possibility that abrasive grits might be embedded in the gold alloy surface. Although the background of oxygen was rather high due to the existence of gold, the distribution of oxygen was obviously different from that shown in Figs. 1 to 4. This means that the contamination of titanium was related to its reactivity as well as its hardness.

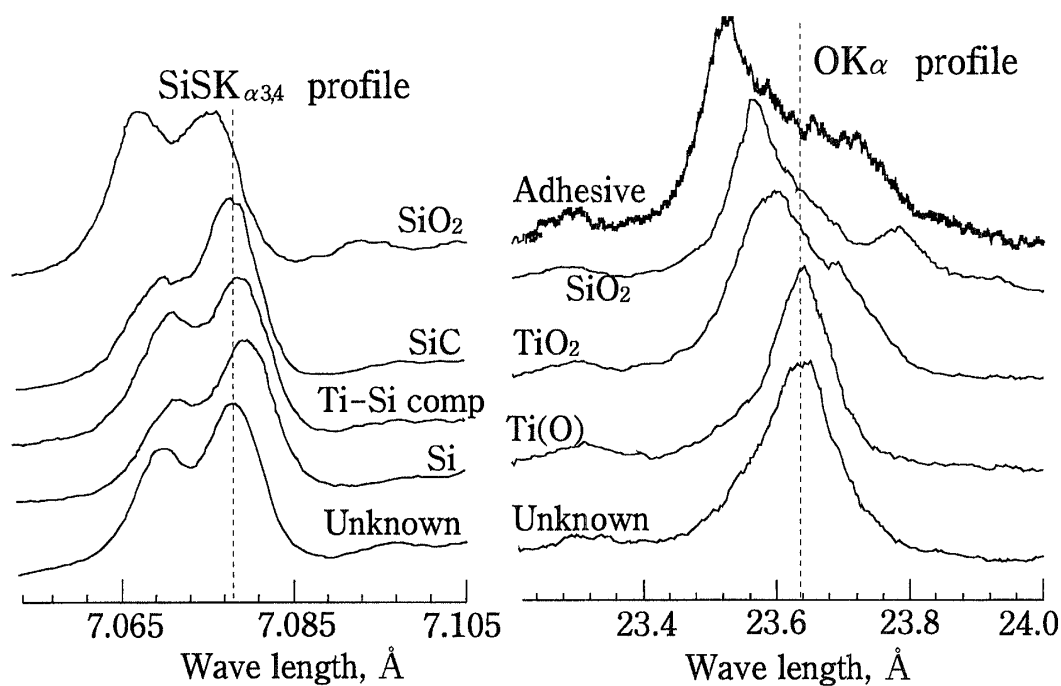
Fig. 7 Chemical bond states of Si and O on an abraded Ti surface. The profiles of Si satellite $K_{\alpha 3,4}$ and O K_{α} spectra of the contaminant were compared with those of standard substances. "Ti-Si comp" represents a net-shape and titanium silicide-like phase existing in the reaction zone of a titanium casting. "Ti(O)" is solute oxygen in the α -case of a titanium casting.

To determine the properties of the contaminant deposits, chemical bond state analysis was performed focusing on silicon and oxygen. The results shown in Fig. 7 indicate that the chemical bond state of the silicon was similar to that of silicon carbide or a titanium silicide⁴⁾, neither silicon oxide nor silicon. The state of the oxygen was close to that of solute oxygen in titanium.

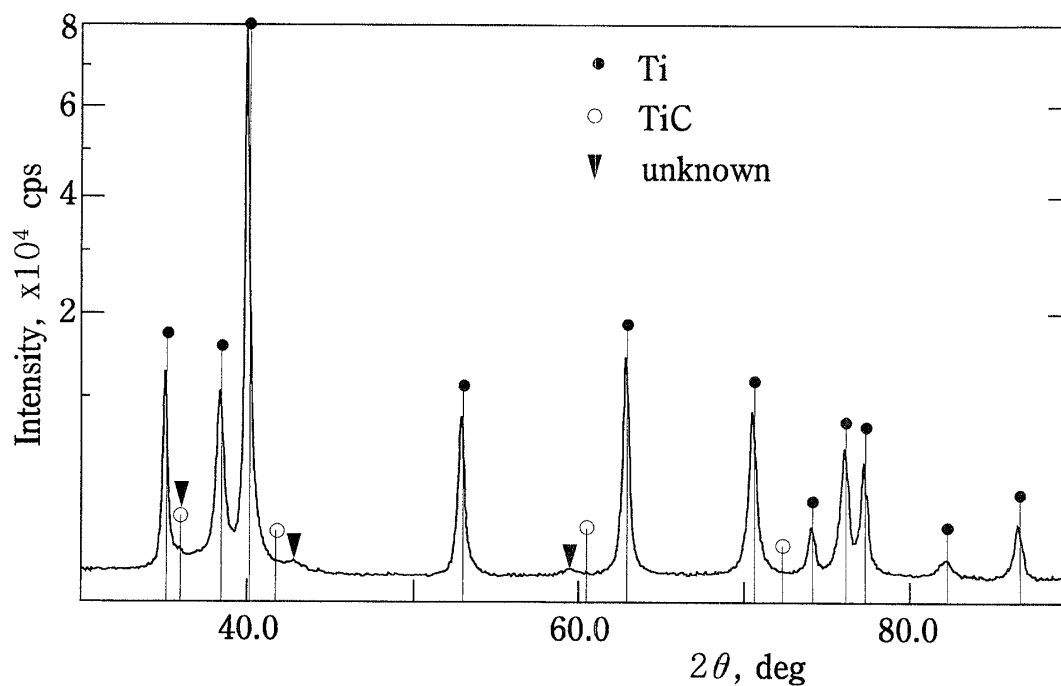
Fig. 8 An X-ray diffraction chart of an abraded Ti surface (Bragg-Brentano method). The resin-attached specimen was abraded to #1,000 grit. Refer to Table 1 for "Ti" and "TiC"

In order to identify the contaminant deposits, the abraded surface was analyzed by X-ray diffraction. Fig. 8 shows a chart of diffraction by the Bragg-Brentano method. In Table 1, peaks obtained in Fig. 8 were compared with standard peaks of the following substances: α -titanium, titanium carbide, silicon carbide, silicon, graphite, and titanium silicides such as Ti_5Si_4 , Ti_5Si_3 , TiSi and TiSi_2 . Except for three peaks of very slight intensity (arrow heads in Fig. 8), all the major peaks (solid circles in Fig. 8) were identified as α -titanium with a confidence coefficient of 865, as shown in Table 1. However, the confidence coefficient for titanium carbide (open circles in Fig. 8) was 225 and those for the other substances were lower. In other words, the three unknown peaks could not be identified clearly, suggesting that the major portion of the contaminant deposit might be amorphous or very thin.

Peaks obtained in Fig. 8 were compared with those of the following possible substances; α -Ti, TiC, SiC, Si, graphite, and titanium silicides such as Ti_5Si_4 , Ti_5Si_3 , TiSi and TiSi_2 . Substances with confidence coefficients lower than 100 are omitted from this table.
