# Measurement Experience of Lightning Currents to Wind Turbines

YOSHINORI UEDA\*1      SHINJI ARINAGA\*2  
 MITSUYOSHI FUKUDA\*3      NOBUKI IWAI\*3  
 TAKATOSHI MATSUSHITA\*3      KOSUKE INOUE\*1

Wind power generation is growing rapidly and is acting a main role for preventing global warming. Yet the number of wind turbine failures due to severe weather conditions in Japan has been increasing. The foremost cause for this increase in the failure rate of wind turbines has been lightning. The coastal area of the Japan Sea in the Hokuriku region are prone to "Winter Lightning," a form of high-energy lightning which is rare in most other parts of the world. Winter lightning damages many wind turbines in Japan every year. Mitsubishi Heavy Industries, Ltd. (MHI) has observed and measured "Winter lightning" which strike actual wind turbines in Japan since 2002. By doing so, the company hopes to establish a technology for rapidly releasing the lightning energy to the ground whenever lightning strikes. In this paper, the authors analyze lightning current measurements recorded by wind turbines struck by lightning in various regions of Japan. Observed data reveals that IEC61400-24 protectio

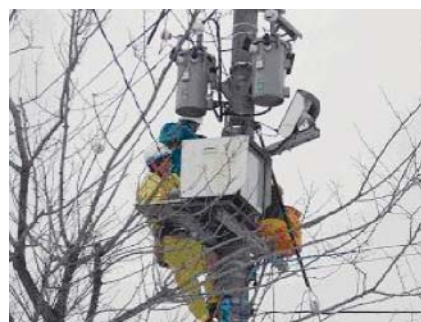
Fig. 6 Camera observation device for lightning strikes

MHI started its lightning observations in the 600 kW wind turbine set up at the peak of Goishigamine, at the root of the Noto Peninsula in Ishikawa Prefecture, in 2002. The Rogowski coil was set in two places, i.e., the main shaft and tower base, to distinguish between the lightning strikes on the turbine blades and those on the lightning conductor on the nacelle (**Fig. 4**). MHI also installed a lightning strike observation camera (**Fig. 6**) in cooperation with the Lightning Center of Hokuriku Electric Power Co., in order to establish a system to visually observe areas struck by lightning.

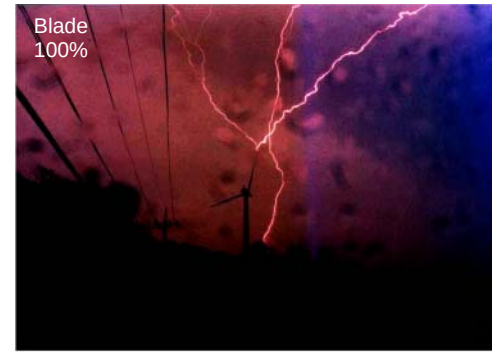
Fig. 14 After a receptor was adopted

This was confirmed by camera observation (**Fig. 13** and **Fig. 14**). It also appears that the overall frequency of lightning strikes on the wind turbines increased by 1.5 to 10 times after the receptor blades were replaced. But given that the seasonal variation was as large as 1.5 times to 5 times, we cannot affirm that the blade replacement had a decisive effect.
